A GEOTECHNICAL CASE STUDY OF FOUNDATION PERFORMANCE OF A BUILDING IN HOT WATER SPRING AREA

Dovendra Sharma and G. S. Mohrotra

ABSTRACT

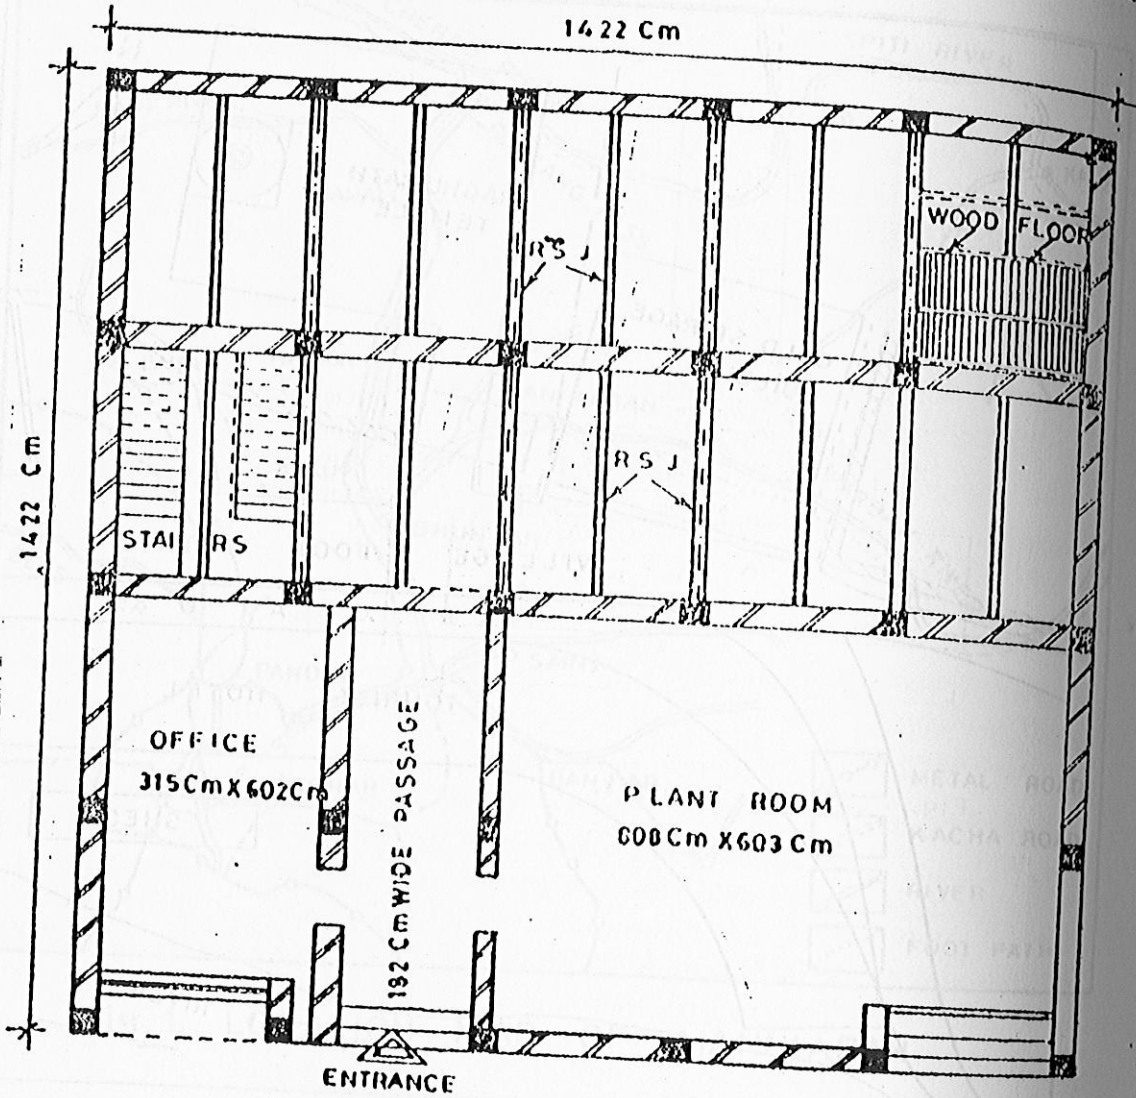
Fig. 3. GROUND FLOOR PLAN

The river course at the Manikaran is approximately east to west and the whole village is situated on a terrace at the all foothill (Fig. 2). The cold store building is in the vicinity of Sri Ram Temple. The building is 14.22mx14.22m in plan (Fig. 3) having the office room and the Plant Room in the front portion with a covered passage in between the two leading to the Cold Storage area. The walls are of one-and-a-half brick thick, with 35cm thick plaster inside and exposed brick work in the exterior. The maximum height of the cold storage side walls is 9.33m while the front portion is about half of this height. The walls have 38cmx23cm RCC columns in the brick walls to support the loads of the stored materials and the roof trusses with A. C. Sheets. There is three tier storage space having a clear headroom of 2.25m. The intermediate floors are of RSJs and wooden jafri. The finished floor level was in the front portion at 45 cm above the ground level. To accommodate the air space and RSJs etc. The floor level in the store is about 18cm lower than the ground level. Under the floor the filling was done by the local coarse sand and it had the usual specifications of 38mm top concrete finish over 76mm lean concrete. However, in store room floor, instead of lean concrete, the concrete as in top was used. The actual ground level was only a few cm below the floor level of the plant room.

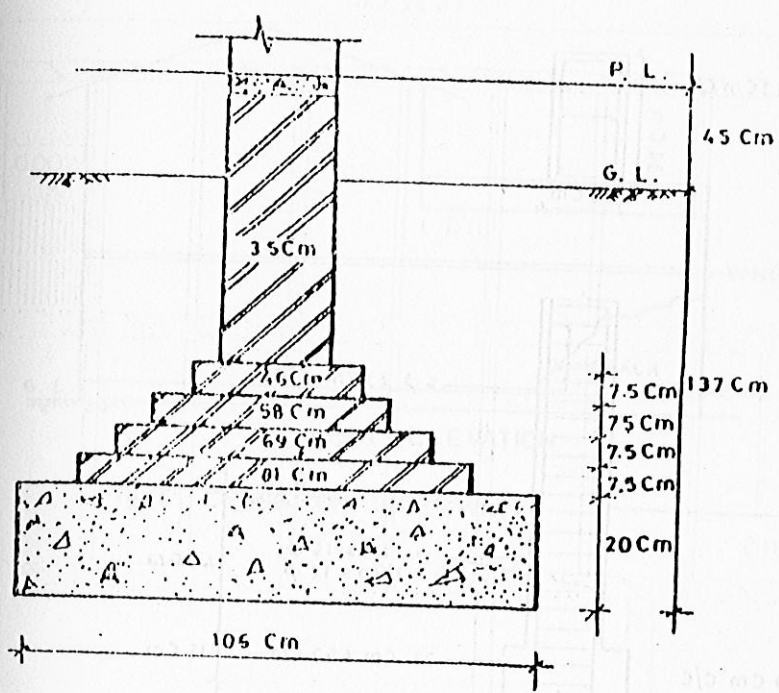
Fig. 4. STRIP FOOTING

The width of the strip footings is 1.05 m and the column footings are 1.80 m x 0.97 m in dimension. Their depth is about 1.35 m in both the cases (Fig. 4 & 5). Reinforced concrete bands have been provided in the building and these are connected to the columns. There are two bands in the storage room walls which are higher. These bands seem to have been provided as an anti earthquake measure as the site is in earthquake Zone V. The quality of the masonry and concrete work was according to the specifications. Reasons for cracking could not be attributed to the performance of the superstructure as there was no deterioration of the materials and there was no excessive loading. The plant did not run and there was no storage of materials. The substructure performance, including behaviour of strata could be the reason.

The foundation of the walls and columns are of the same description for the whole building. It seems that for foundation design, loads might have been worked out for storage portion and the same foundation had been adopted all over the building. The bearing area of RCC footing is 1.80 m x 0.97 m and if 5t/sq. m. were the bearing pressure, the footing can safely carry a load of 17.50t. Similarly a one meter length of strip footing of 1.05 m width will carry a safe load of 5.25t. These back calculations reasonably match with the expected likely loading in the storage portion. In fact, these are on safer side and excessively so for the front portion, where there is no storage, and wall heights are almost half. The assumption of safe bearing pressure of 5t/sq. m is the lowest likely value for cohesionless soil strata. Thus, it can be concluded that foundations are adequate, and under normal case there should not have been any problems on account of their performance.

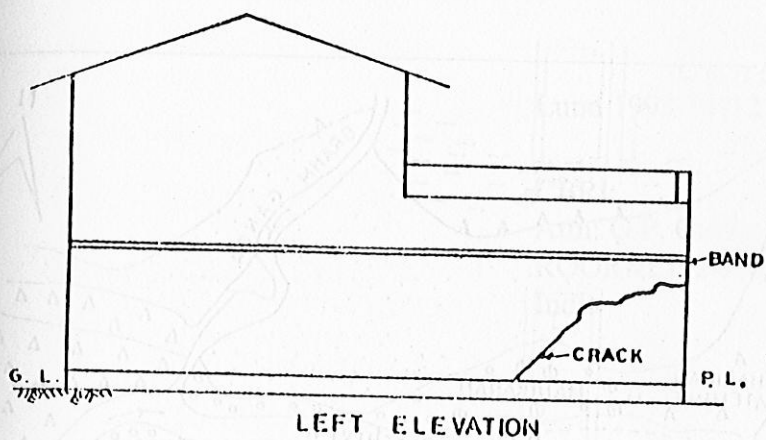
The construction of the building was completed in 1983. The cracks were first observed in May, 1985 in the front and on the side walls of the building, subsequently further development of cracks were noticed. The building was inspected in detail in February 1987. The front portion of the building comprising the office room and the plant room (Fig. 3) showed separation of the walls at their junction with the cold storage. The cracks were wider at the top. The crack width in the Plant Room was 4.1cm at a height of 3.75m. Two prominent cracks had also developed on the side walls (Fig. 6 and 7) of the Office Room and the Plant Room. Besides, there were some diagonal cracks at window corners, a horizontal crack at the top of the lintel of the entrance passage door and several other cracks of minor and mixed nature.

The nature of cracks in the office room and in the Plant Room is indicative of foundation movements. The wider cracks at the top and cracks on the side walls show that the front portion consisting of the office room and the Plant Room have suffered from differential settlement of foundations. The general slope of the ground is towards the river and the flow of water,

Fig. 6. CRACK ON SIDE WALL

The building cracks can be repaired by filling, stitching and rebuilding and relaying of the floors. The problem has been due to seepage of the water and consequent likely loss of material from the ground which has

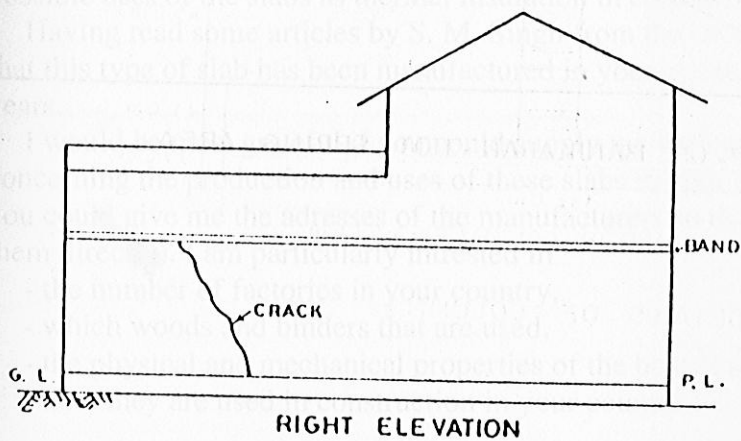
Fig. 7. CRACK ON SIDE WALL
