# Remedial Underpinning for Foundation of a Steel Tank— Construction Details

Prof Dinesh Mohan, Fellow  
Dr R K Bhandari, Member  
Chandra Prakash, Associate Member  
B Sivaram, Non-member

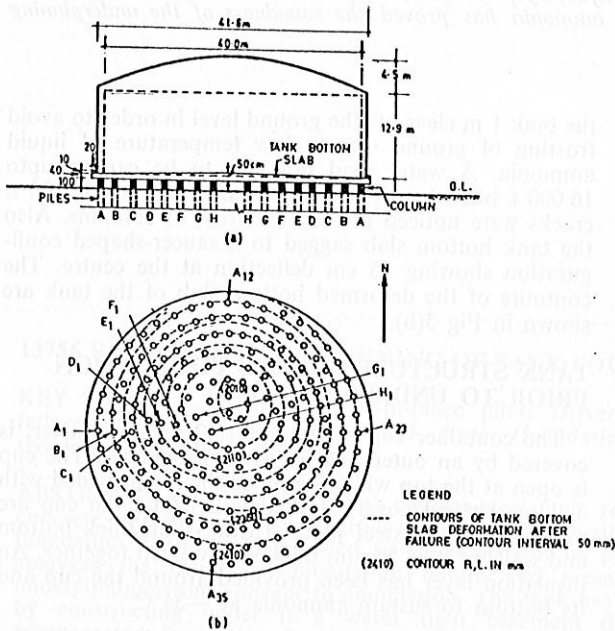
Fig 3 Details of ammonia tank

the tank 1 m clear off the ground level in order to avoid frosting of ground due to low temperature of liquid ammonia. A water load test was to be carried upto 16 000 t but when it reached a value of about 8 100 t, cracks were noticed in the outer row of columns. Also the tank bottom slab sagged to a saucer-shaped configuration showing 45 cm deflection at the centre. The contours of the deformed bottom slab of the tank are shown in Fig 3(b).

The tank is circular in shape and was constructed on a flexible RCC raft (tank bottom slab) supported by 217 cast-in-situ concrete piles driven concentrically in circular rows (numbered A to H) as shown in Fig 3(a). The piles were of 50 cm diameter and were driven down through 26 m soft clay deposit into 8 m of stiff clay and finished 1 to 2 m below the ground level. The piling firm, based on their experience, available soil properties and a load test on similar pile in the area, assigned a safe load of 88 t on each pile. Over the pile tops, RCC columns of equal diameter were raised for supporting

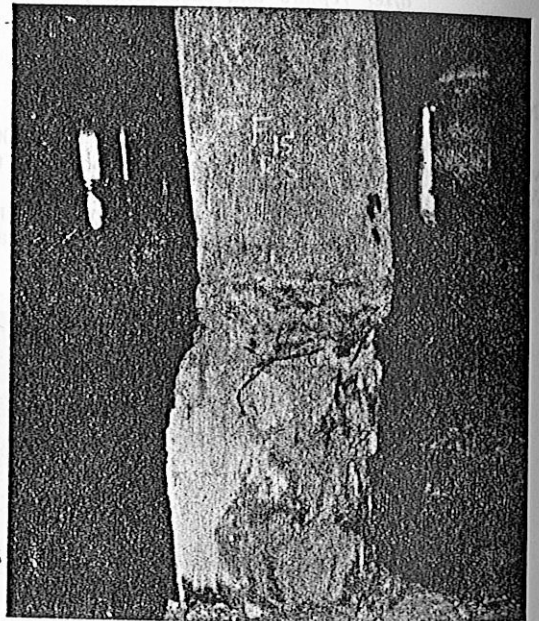
Fig 4 Defective pile-column joint

In the piles of the outermost row (A), reinforcement was provided to a depth of 25 m and in all other piles to a depth of 6 m only. The pile-column joints were found to have large eccentricity which was revealed during the excavation of basement during underpinning. The eccentricity was noticed in about 70% of the piles,

the minimum being 54% in Row D and maximum 77% in Row E. Also, about 77% pile-column joints had either bad concrete or clay gouge, the minimum being 50% in Row H and maximum of 90% in Row C. In a few piles, even below the joints, bad quality of concrete reduced pile size and other piling defects were noticed. The condition of a typical joint is shown in Fig 4.

As the excavation progressed, the condition of exposed piles and pile-column joints could be examined. Piles having large eccentricity, bad concrete at joints and ill placed reinforcement were common. The work of pile repairs was taken up simultaneously so as to complete it before lifting of the bottom slab of tank. For repairing the defective piles and joints, the repair work was categorized into columns of eccentricity, namely, (a) less than 8 cm, and (b) more than 8 cm. In the first case, piles having poor joints were cleared of bad concrete and during this process, the self weight of the slab was supported with clamps (Fig 7). After removing

the bad concrete, reinforcement was straightened. Also wherever necessary, a RSJ (having plates welded at both ends) was added and extra reinforcement was welded. A rich concrete mix of high slump was then poured after providing appropriate shuttering. In case of piles with larger eccentricities, the reinforcement in the pile section was extended vertically upto about 50 cm below the slab. Then it was cast in the form of round concrete column. Exposed piles having any other defect were also repaired suitably.
