# RECONSTRUCTION OF A BATHROOM FIRE

By Sunil K. Sharma, Scientist, Fire Research,  
Central Building Research Institute, Roorkee (UP) 247 667 INDIA

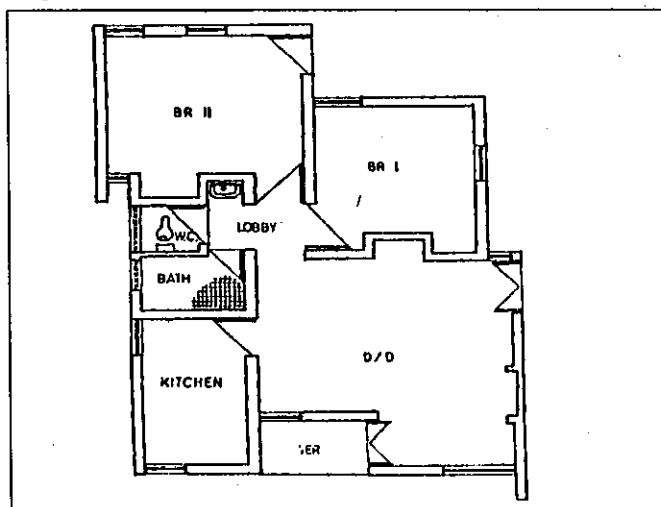
Fig. 1 Plan view and the site of fire

Fire took place in the bath room of one of the ground floor apartment. The bathroom had a geyser (storage type wall mounted unit) and a semi automatic twin tub washing machine as the main electrical appliances.

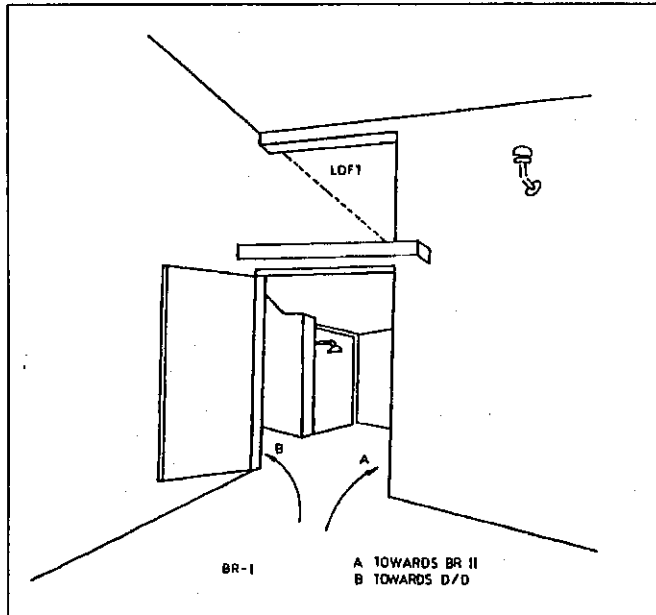
Lot of smoke had accumulated under the loft (Figure 3) because of the reduced ceiling height at the circulation space (lobby) connecting the bath, WC, the two bed rooms (BR I & BR II ) as well as the drawing cum dining room (D/D). Smoke deposits indicating the path of smoke movement

Fig. 3 Loft under which smoke accumulated

was observed under the loft which is located at 2.0 meters height from the floor level and on heavy cotton curtains leading to the two bed rooms. Since the smoke had also logged the two bed rooms, smoke deposits were found in both the bed rooms clearly indicating the 'would be' path of fire which could only be averted by the timely action taken. The curtains were very warm to touch (may be of the order of 75-80° C), and it would have only been a matter of time when the wooden door of the bathroom would be fully involved in Fire resulting in higher temperature and further spread of fire to other parts of the apartment.
