Photographic Feature

Varunavat landslide disaster in Uttarkashi, Garhwal Himalaya, India

Abstract: Uttarkashi town, Garhwal Himala, India was severely affected by the Varunavat hill landslide, which occurred on 23 September 2003. The houses situated at the foot of the hill were completely destroyed; however, there were no casualties. The paper describes the landslide, its features, probable causes and associated risk as observed by the authors.

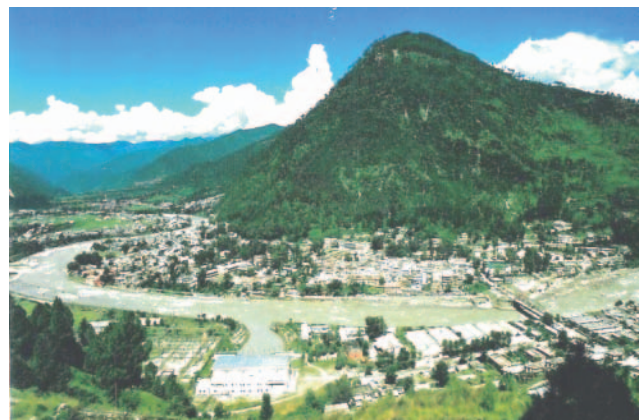
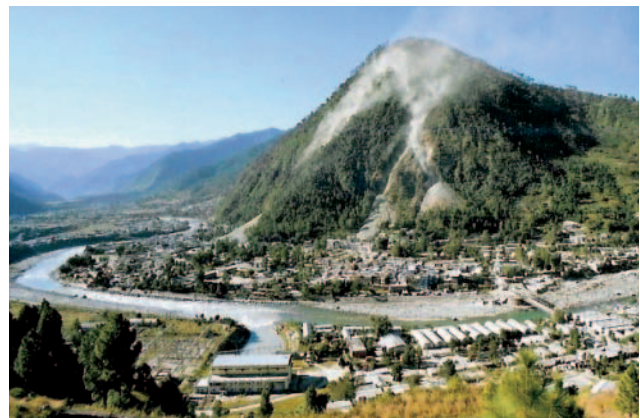
Fig. 1. (a) Pre-landslide scenario and (b) post-landslide scenario of the Varunavat hill.

Slope instability of the Varunavat hill has been documented by Pandey & Uniyal (2007), who described two previous landslides (Fig. 1). The Gyansu slide occurred in June 1980 and since then debris comprising boulders and loose unconsolidated material has frequently been mobilized down the Gyansu drain into the Bhagirathi

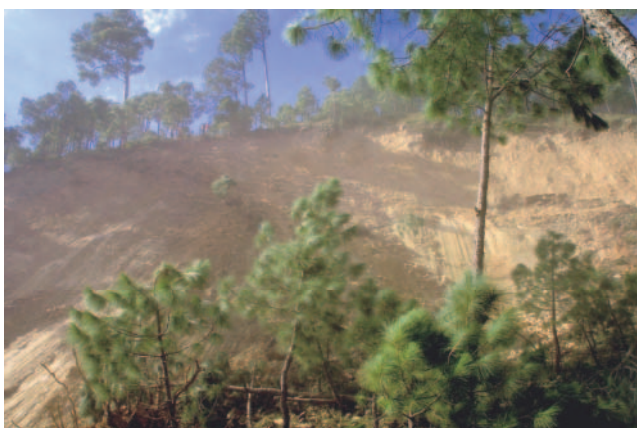
Fig. 2. Main escarpment of the landslide.

The main scarp of the slide was about 60–70 m wide and 650 m above the road level (Fig. 2). The exposed slip surface was 100 m or more in length with a dip of up to 40° (Fig. 3). The striations caused by the movement on the slip surface were distinctly visible. The runout distance from the exposed slip surface to the zone of accumulation in the town was more than 900 m. The slope was steep in the lower portion of the hill. Once the slide was triggered the impact of boulders on rock outcrops and soil overburden resulted in entrainment of more landslide debris. The debris material comprised boulders and rock fragments of various sizes along with mixed sandy and silty clay. Several cracks were observed in the main body of the landslide. A few of these were more than 1 m deep. Most of the cracks were transverse in nature, and there were a few longitudinal cracks. Cracks were also observed on the slopes along the left flank beyond the limit of the landslide. This indicated the possibility of further lateral extension of the landslide on the left flank. The volume of displaced debris

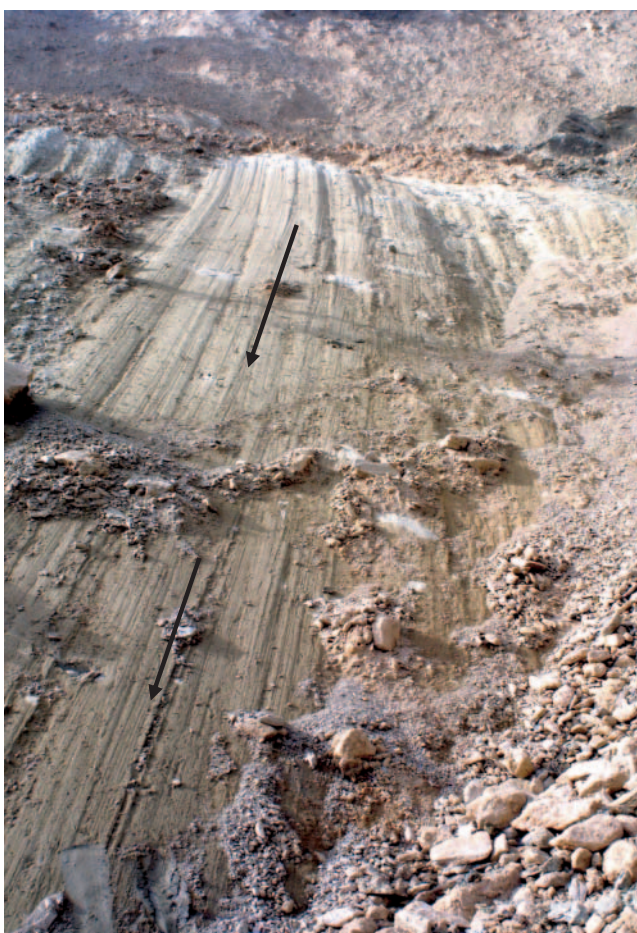
Fig. 3. Slip surface showing striations caused by sliding.

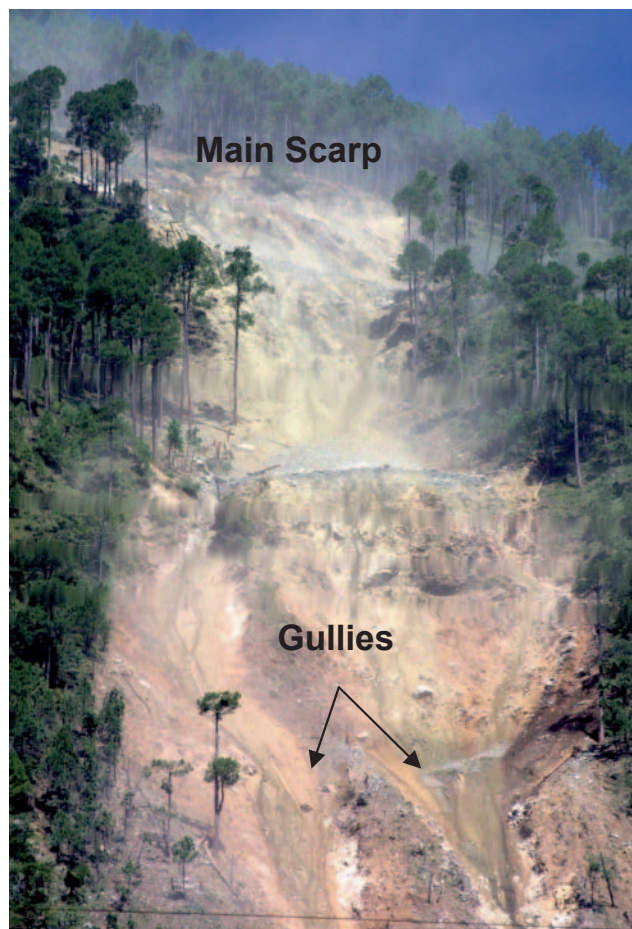
Fig. 4. Continuous debris slide and rock fall.

resting on the upper part of the slope was estimated to be about 40 000–50 000 m³. At the time of survey, debris was observed to be continuously rolling down the slope and posing a threat to the houses situated in its path (Fig. 4). A huge quantity of debris accumulation at the toe of the slide in the form of a colluvial fan destroyed several structures including residential, shopping and hotel buildings (Fig. 5).

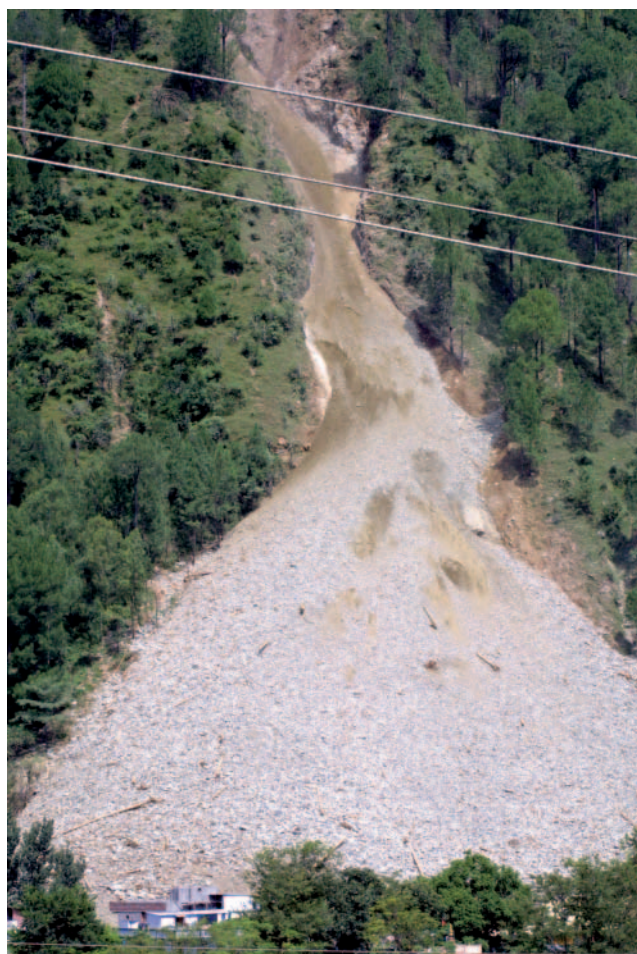
Fig. 5. Debris accumulation at road through the main channel.

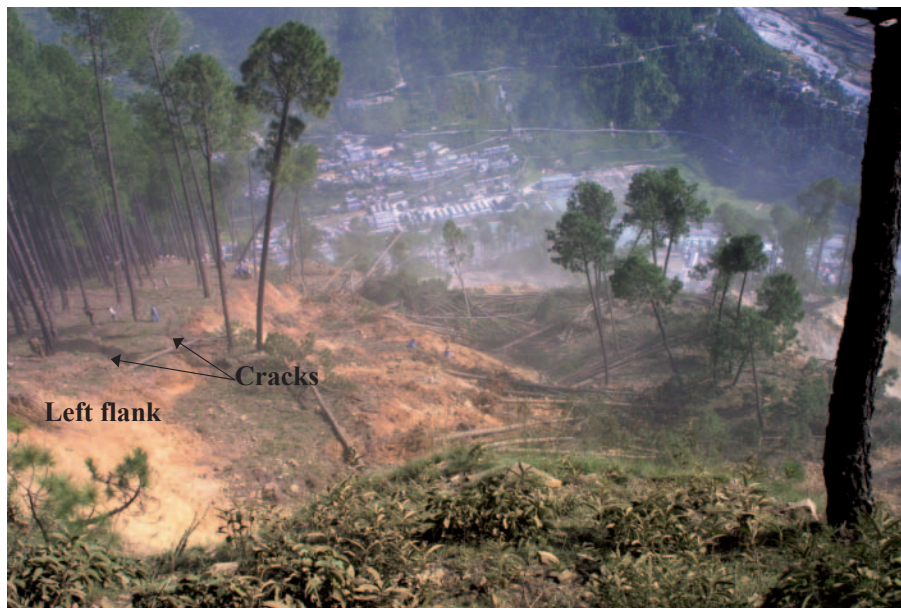
Fig. 6. Uprooted trees on uphill slope.

The movement of debris also affected the forest in its path, resulting in the uprooting of trees. Two breaks in slope with gentler slope angles between 15 and 20° were observed along the flow path, and served as temporary accumulation zones for the sliding mass and uprooted trees (Fig. 6). Thus the accumulation of slide debris

along with uprooted trees at various elevations on the slope locally increased the gravitational load and aggravated the slope instability. Because of the accumulation of debris in the main path a new channel formed down the left flank of the slide (Fig. 7). This new channel threatened a large number of houses in the town. The local administration was advised to evacuate these houses immediately.

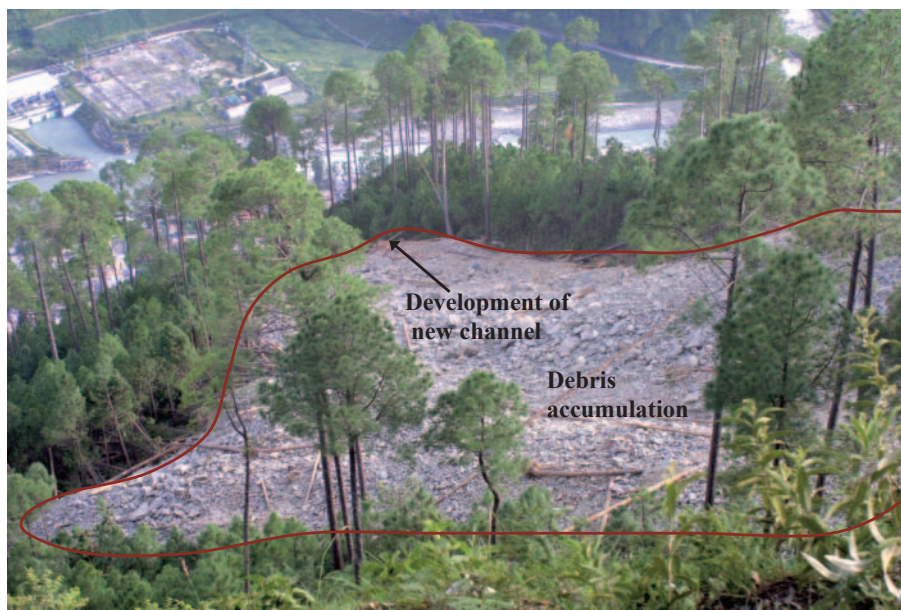
Fig. 7. Development of new channel for debris slide and rock fall.

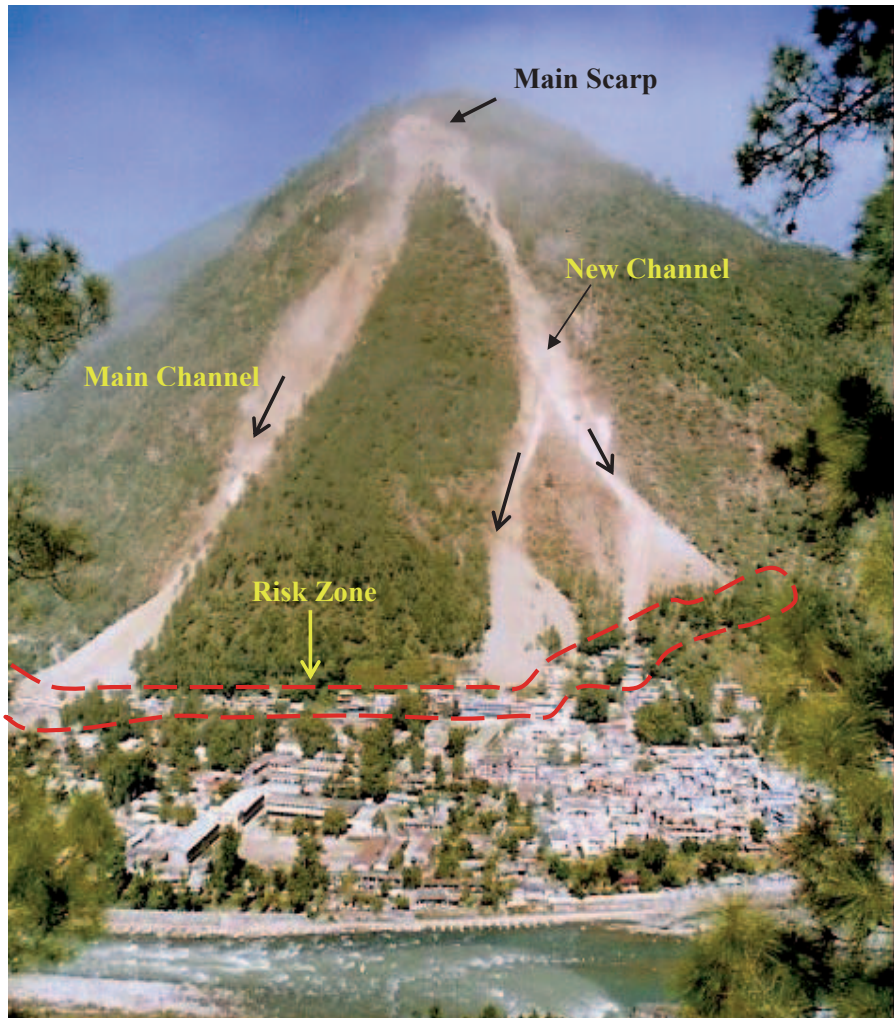
Fig. 8. Suggested buffer zone at risk owing to landslide.

and followed the recommendations. As predicted by a team of experts (formed by the Ministry of Home Affairs, Government of India) including the authors, a huge quantity of debris was displaced down the left flank within a week after the new channel formed (Fig. 8). It was also suggested that remedial measures such as sealing of cracks, slope grading, construction of retaining walls, proper drainage measures, soil reinforcement and biotechnical measures should be designed and implemented once the sliding activity stopped.

In view of the loose debris resting on the slope above the steep foot-hill slope, it was recommended that a buffer zone of about 100–150 m width and 1 km length along the foot hill be created to avoid any further damage, particularly that owing to rock fall. The extent of the buffer zone was decided keeping in mind the

volume of debris and the flat topography at the foot hill. It was advised that no development or construction activities should be allowed in the buffer zone, which

should remain under strict vigilance until the sliding activity completely stops and the hill slope can be declared safe. The administration took prompt action

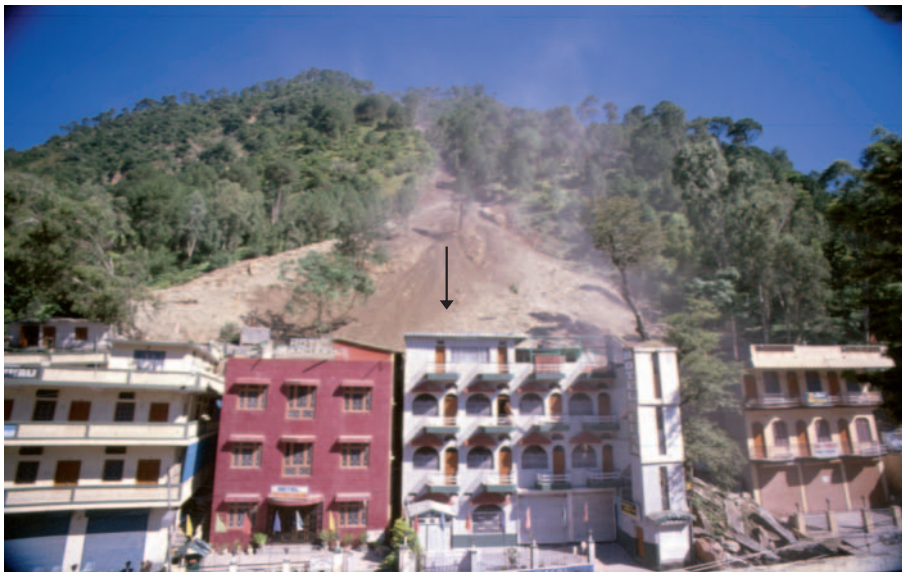
Fig. 9. Buildings that were later buried by debris.

The landslide has destroyed many structures. About 360 houses were completely or partly damaged by the landslide (Fig. 9). Hotels and tourist lodges located along the National Highway (108) were completely buried under the thick cover of landslide debris. Residential houses and government buildings were also affected. The National Highway was blocked for a month over a 1 km road length. There was also loss of forest on the uphill slope of the hill owing to the movement of boulders and debris material. However, there were no casualties, as the district administration along with scientific organizations worked together to evacuate the houses in time. This avoided a potential major disaster.

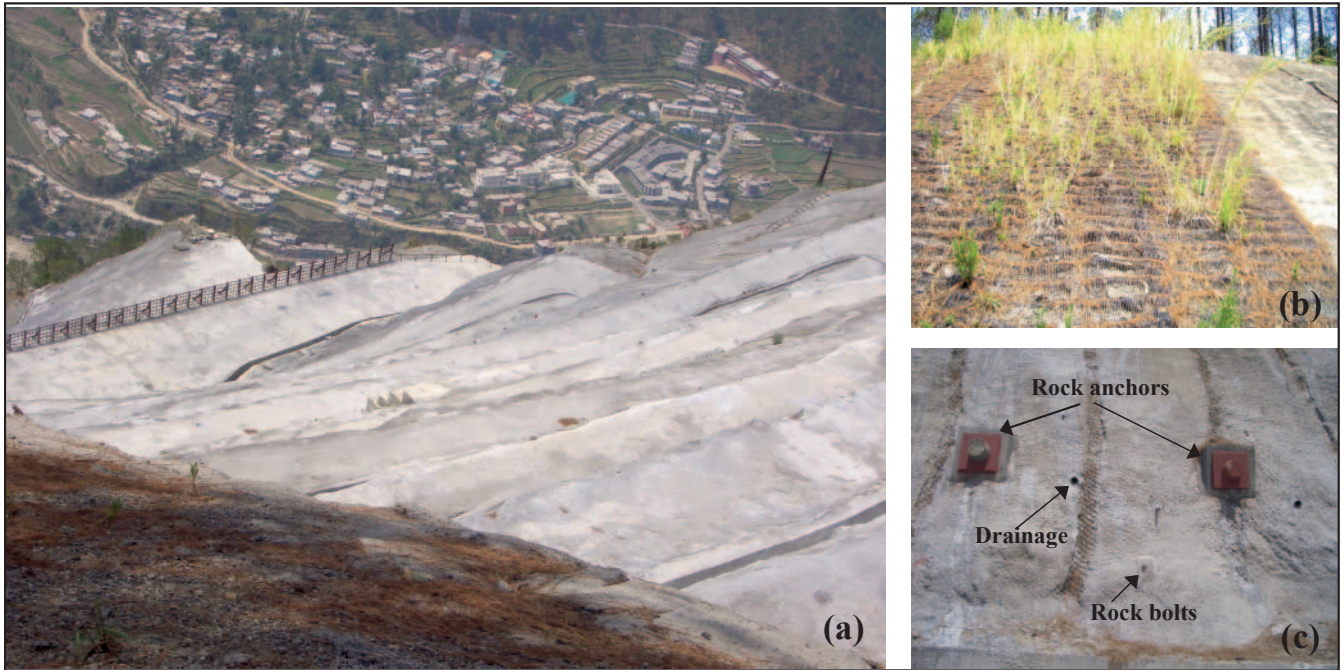
Fig. 10. Present scenario after implementation of control measures. (a) View of landslide from top. (b) Bio-measures at main scarp. (c) Rock anchors, rock bolts and subsurface horizontal drains.

The control measures were implemented during 2008–2009 (Fig. 10). The slope has been modified and shotcreting has been applied with wire mesh reinforcement on the entire slope. Rock anchoring and rock bolting has been implemented to strengthen the weak jointed and fractured rocks. After covering the main landslide scarp at the crown portion with geo-grid, bio-measures have been adopted to protect the slope from erosion. Special grass has been planted to stabilize the slope through root reinforcement. Subsurface horizontal drains have been installed at various levels to drain groundwater. Surface drainage has also been constructed at various levels to drain surface runoff from the slope. At the toe, a retaining wall was constructed to provide support to the slope. At present, the slide appears to be stabilized and no activity was reported after the implementation of the above control measures.
