Landslide disaster on Berinag–Munsiyari Road, Pithoragarh District, Uttarakhand

S. Sarkar and D. P. Kanungo

The landslide disaster on 8 August 2009 near Kuity village in Pithoragarh district of Uttarakhand State buried two villages and took 43 lives. The landslide, triggered by cloud burst resulted in massive debris flow along a stream channel. The site is still in danger as shown by the presence of huge quantity of debris and ground cracks on the slope. Here we present inferences drawn from the field observations.

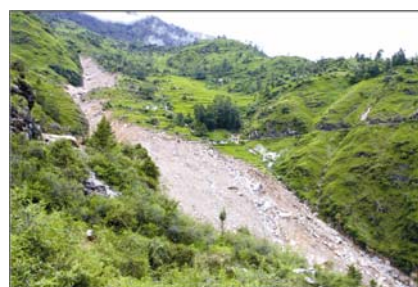
was undertaken on 18 August. Here we present field observations during the survey, probable causes of the slide and the associated risk in the area. A panoramic view of the landslide is shown in Figure 2.

Figure 2. Panoramic view of the landslide.

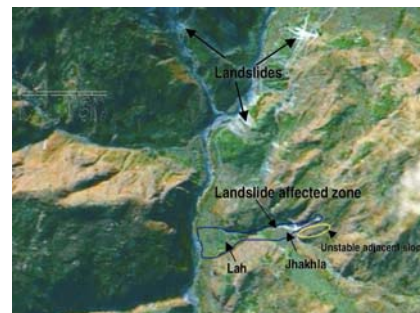
nario of the region as observed in the satellite image available in the recently launched Bhuvan, Indian Earth Observation Visualization (IEOV) has clearly indicated that the Paniyali Gad stream has loose earth material. From this image, it can also be inferred that probably a small landslide scar at higher reaches of the stream was present prior to the recent event (Figure 3).

Figure 3. Pre-landslide scenario as seen in Bhuvan satellite image.

As observed from the Bhuvan satellite image of pre-landslide scenario of the area, it is inferred that a landslide escarpment existed on the upper reaches of the Paniyali Gad stream. The stream flows towards NE direction up to the road level and changes its direction towards east below road level. Before meeting Jakula river, the stream gets bifurcated into two different channels. Lah village is situated close to the river bed between these two channels and Jhakla village is situated on the northern side/left flank of the Paniyali Gad stream just below road level.

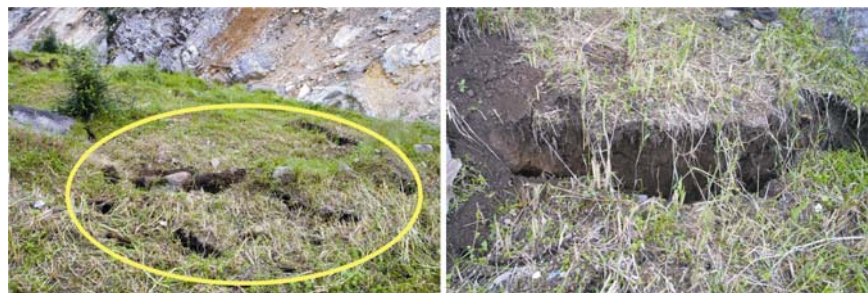
the debris resting on the slope below the road is about 30° . The right flank of the slide along the channel has fractured and jointed rocks dipping 25° towards 20°N . The slope is very steep on the right flank. On the left flank, the slope has agricultural land having a general slope angle of $20\text{--}30^\circ$. The slope has a thick soil cover with occasional rock outcrops. Numerous ground cracks have developed on this slope due to the landslide (Figure 5). The cracks are transverse and longitudinal and a few of them are visible up to 1 m deep and 40–50 cm wide. The cracks seem to be active and still widening. This clearly indicates that the slope is still active.

Figure 5. Ground cracks on the left flank developed due to landslide.

Several cracks were observed on the slope and it was found that the cracks are still widening which shows the existing slope instability condition of the area (Figure 5). These cracks can serve as openings for rain water to infiltrate and create pore pressure, which may further aggravate the slope instability. The houses on the other slopes are far from the present landslide and separated by a major stream. It is difficult to comment at this moment whether all these houses are in danger due to the present sliding activity. However, the adjoining slopes on the left flank can be treated as completely unstable and no one should live or work there. Since there is still huge quantity of debris in the form of boulders, rock fragments and soil mass fully saturated with water present along the

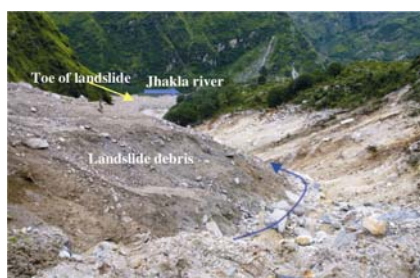
The main escarpment of the landslide was developed at a height of about 80 m above the road level and at a sloping distance of about 200 m. This is a rough estimation as the crown section of the slide was not clearly visible. There are many secondary scars along the stream which were developed due to the impact of debris flow and erosion by the rapid water flow along the channel. The debris moved down along the narrow path in a 10–15 m wide channel. The toe of the slide at river level has a thick pile of debris deposited in a fan shape on a gentle slope. The debris volume resting on the downhill slope is estimated to be of the order of 200,000 cubic metres (Figure 4).

Figure 4. Debris accumulation on downhill slope below road level.

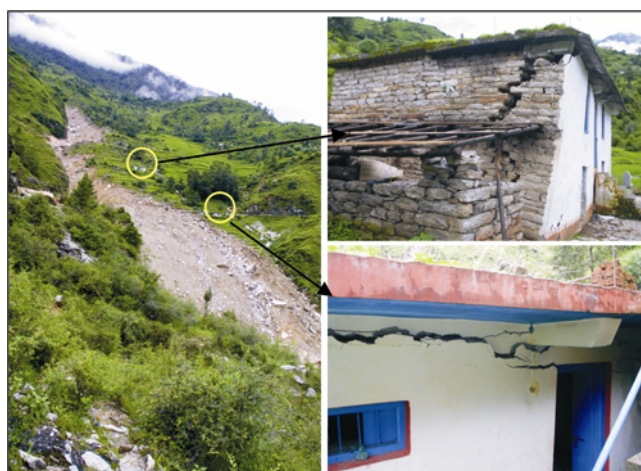
The house below the road level has developed many cracks on the floor and walls. The local people told us that these cracks are still developing and widening. The house on the uphill slope has also

Figure 6. Damaged houses.

developed many cracks. One wall has been completely detached from the roof. The front wall has moved ahead showing a differential movement.

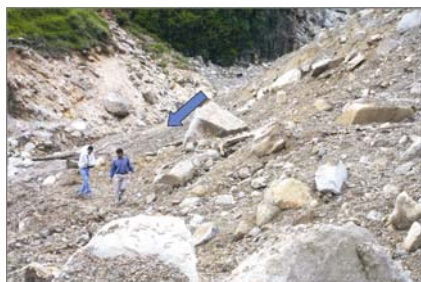
channel above the road (Figure 7), the site is still at risk particularly for traffic. On the day of survey it was also observed that water is still flowing along the channel carrying mud and fine debris. Further, the slip zones adjoining the channel may aggravate the situation during heavy rains.

Figure 7. Debris on uphill slope above the road.

The recent landslide disaster of 8 August 2009 on Berinag–Munsiyari road was due to massive debris flow triggered by heavy downpour killing 43 lives. The presence of huge debris along the stream and below the road and the ground cracks on the uphill slope has indicated that the area is still under considerable risk to life and property. The site needs a detailed investigation to suggest some suitable remedial measures to protect the debris and to stabilize the unstable mass above the road level.

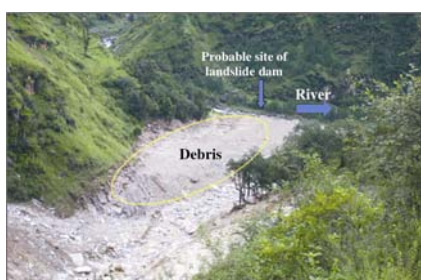
The site also has potential to create landslide dams. If the huge debris accumulated on the downhill slope flows further up to the river level, a temporary landslide dam may develop which can ultimately form a temporary reservoir affecting the upstream catchment of Jakula river and result in subsequent flash flood damaging the downstream of Jakula river (Figure 8).

Figure 8. Risk of forming landslide dam.
