Landslides in the Alaknanda Valley of Garhwal Himalaya, India

S. Sarkar, D.P. Kanungo & A.K. Patra

Central Building Research Institute, Roorkee - 247 667, India (e-mail: shantanu_cbri@yahoo.co.in)

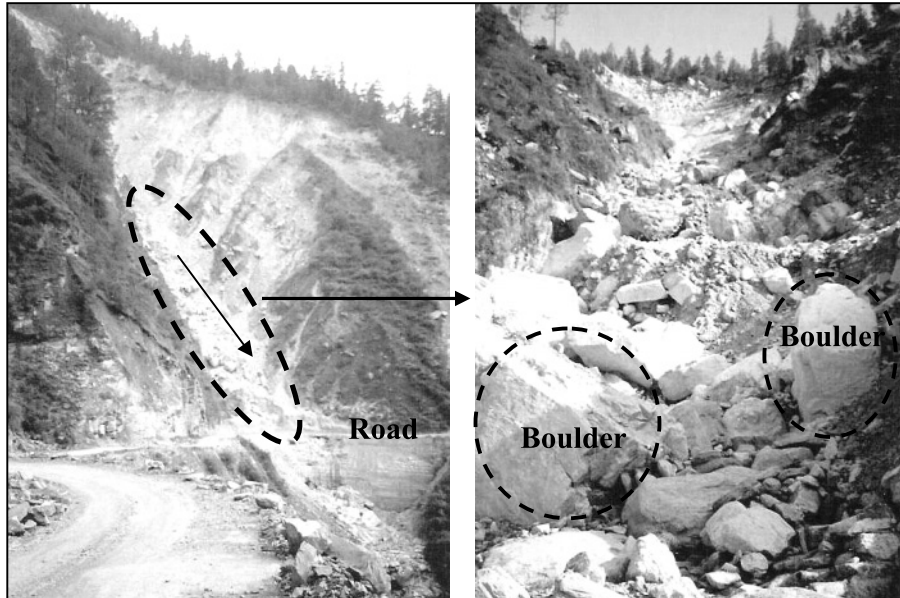
Fig. 2. Debris flow comprising of soil and boulders at landslide 4.

The landslides along Chamoli to Badrinath section of the Rishikesh – Badrinath National Highway are mostly debris slides, debris flows, rock slides and rock falls. Landslide masses are mainly composed of boulders, rock fragments and soil. Debris flows are mostly confined along lines of natural drainage (Fig. 2). Where rock slides have occurred, they are predominantly planar failures along discontinuity that dipping down-slope. In such cases sliding takes place as the rock blocks slide along the discontinuity surfaces (Fig. 3).

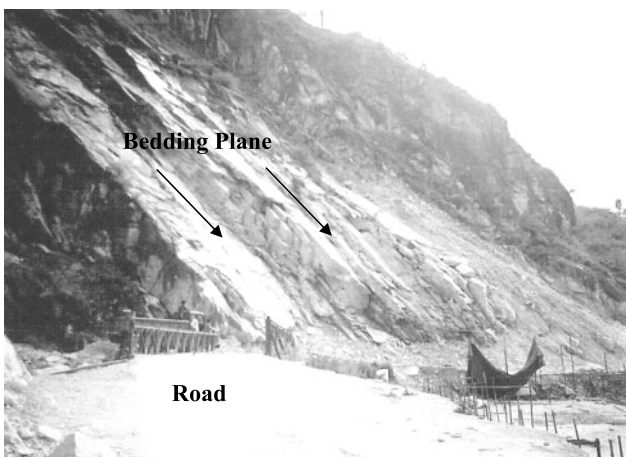
Fig. 3. Planar failure at landslide 3.

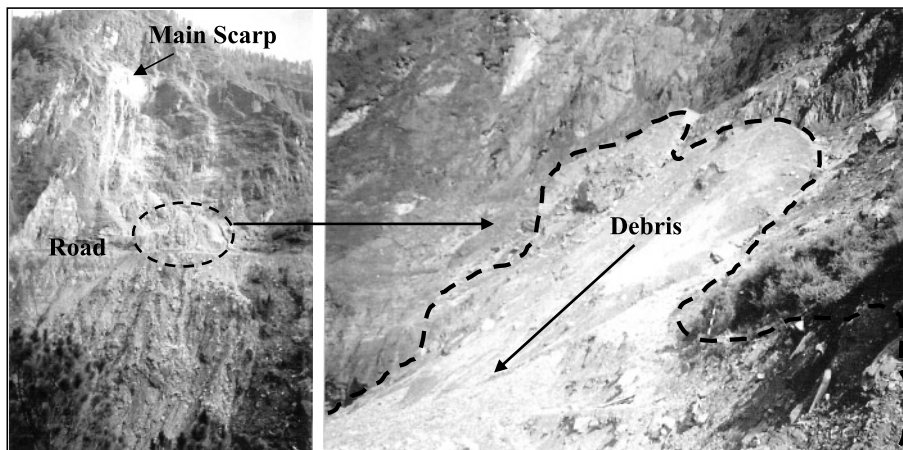
Fig. 4. Landslide 5 on steep of dolomites and slates showing debris accumulation at road level.

to the road level and below (Fig. 4). These materials are often mobilized as debris flows which block the road and sometimes cause fatalities. The volume of the debris on the slope ranges from 5000 to 50000 m³ as observed in the reported slide areas.

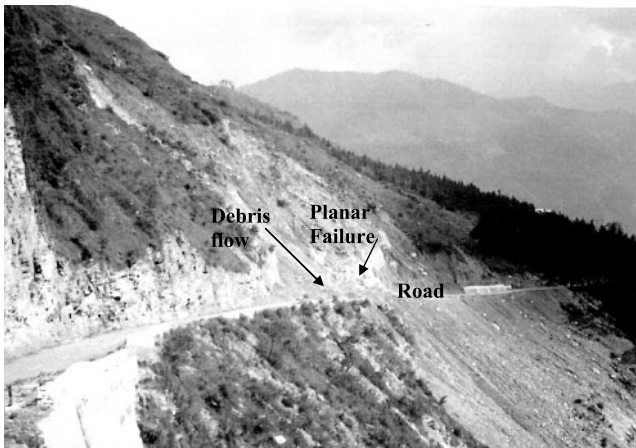
Fig. 5. View of landslide 1 showing multiple failure modes.

Some of the landslides are complex in nature involving multiple failure modes (Fig. 5). The failure modes for this slide may be attributed to planar failures along discontinuities and debris flow of overburden material. Presence of cracks and subsidence on the road indicate shallow rotational failure at road level (Fig. 6). Rock falls are another failure type, which are often catastrophic causing loss of life to anybody in the vicinity. The impact of sudden rock fall depends on the volume of rock mass and the height from which it falls. On many

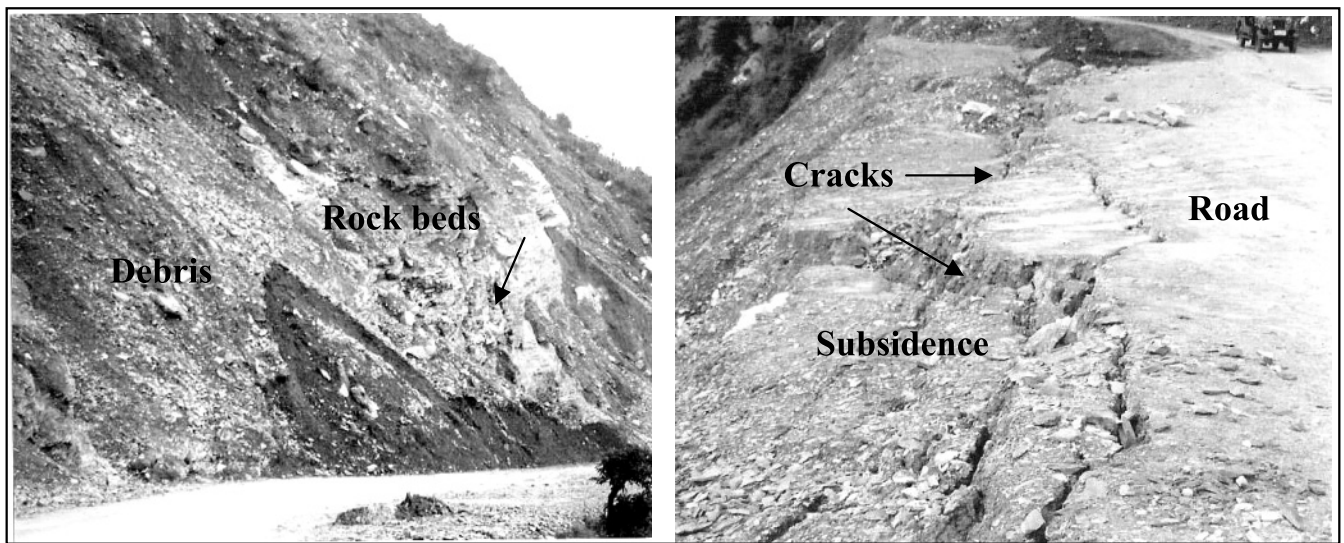
Fig. 6. Debris overburden and road subsidence at landslides 1.

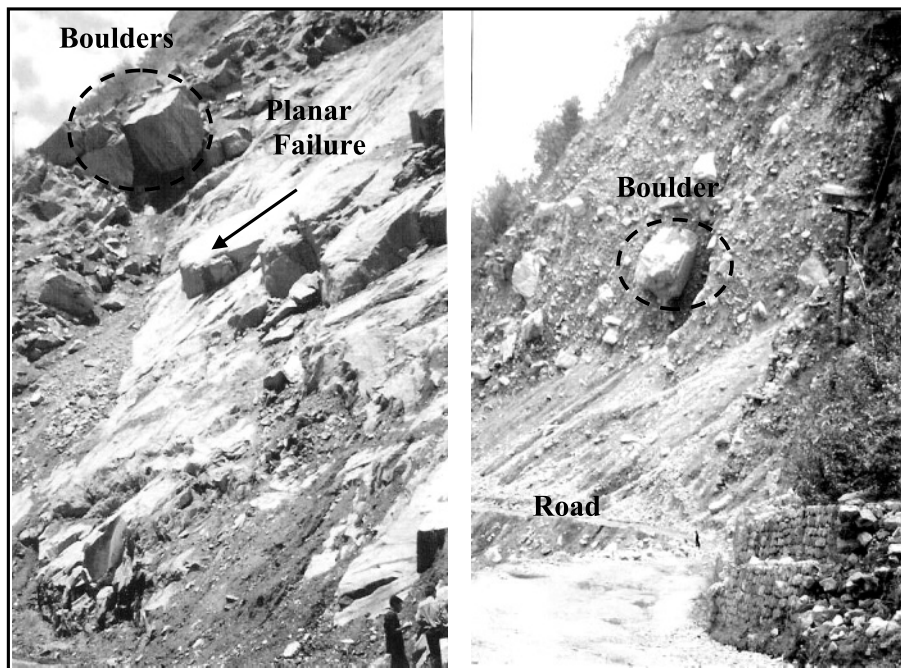
Fig. 7. Risk of risk fall at landslides 7 and 8.

occasions peoples were injured and killed by rock falls striking vehicles. The identification of areas at risk of rock fall is a major issue (Fig. 7).

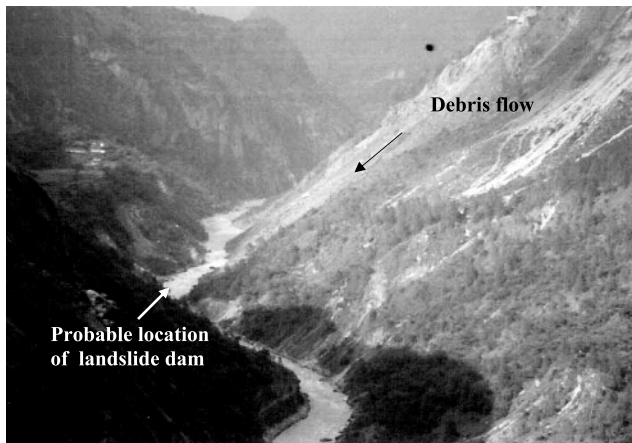
Fig. 8. Potential area for landslide dam.

Historically, several landslide dams have occurred in the Alaknanda valley causing flash flooding downstream when these dams are breached. Such flooding has claimed many lives. The potential for future events remains as there are many slopes from which debris slides occur directly in to the river that can form dams and associated lakes. One such location is shown in

Figure 8 where the narrow width of the river can be blocked to form a landslide dam. Recently a debris flow occurred on the left bank of the river on 26th of September, 2004 triggered by intensive rainfall (Fig. 9). A large volume of debris descended the hill slopes and entered the river partially blocking it for a short time.

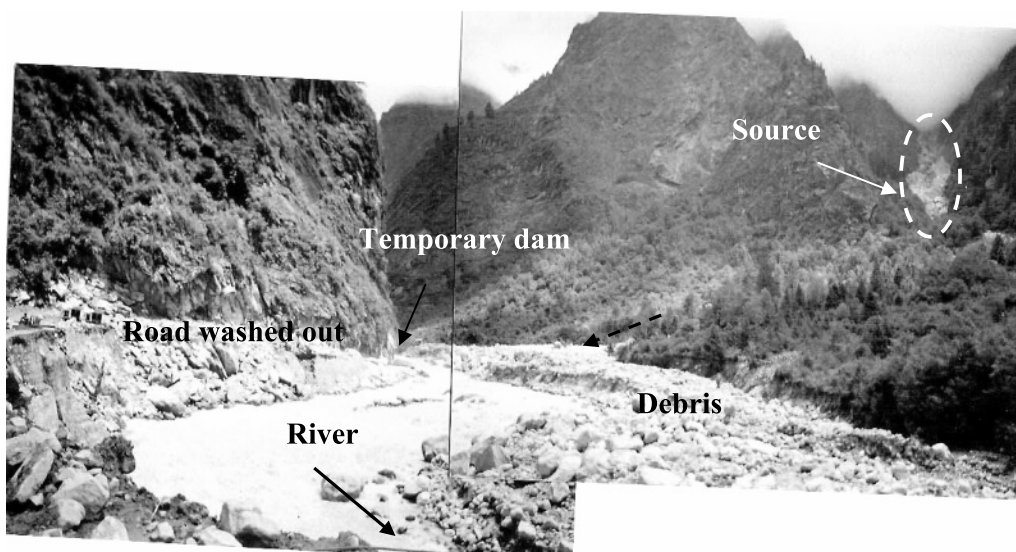
Fig. 9. Massive debris flow at Landslide 9 formed a temporary landslide dam causing change of river course and complete wash out of the road.

This resulted in a change to the water course causing the highway on the right bank of the river to be destroyed. Fortunately this occurred during the night and there was no traffic on the highway. The road was blocked for several months and a new road was built to reach the holy shrine of Badrinath.
