Shantanu Sarkar<sup>(1)</sup>, Amitava Ghosh<sup>(1)</sup>, Devi Prasanna Kanungo<sup>(1)</sup>,  
Zamir Ahmad<sup>(2)</sup>

## Slope Stability Assessment and Monitoring of a Vulnerable Site on Rishikesh-Uttarkashi Highway, India

- (1) Scientist, CSIR-Central Building Research Institute, Roorkee, Uttarakhand, India, e-mail: shantanu\_cbri@yahoo.co.in
- (2) Scientist, CSIR-Central Building Research Institute, Roorkee, Uttarakhand, India
- (3) Scientist, CSIR-Central Building Research Institute, Roorkee, Uttarakhand, India
- (4) Technical Officer, CSIR-Central Building Research Institute, Roorkee, Uttarakhand, India

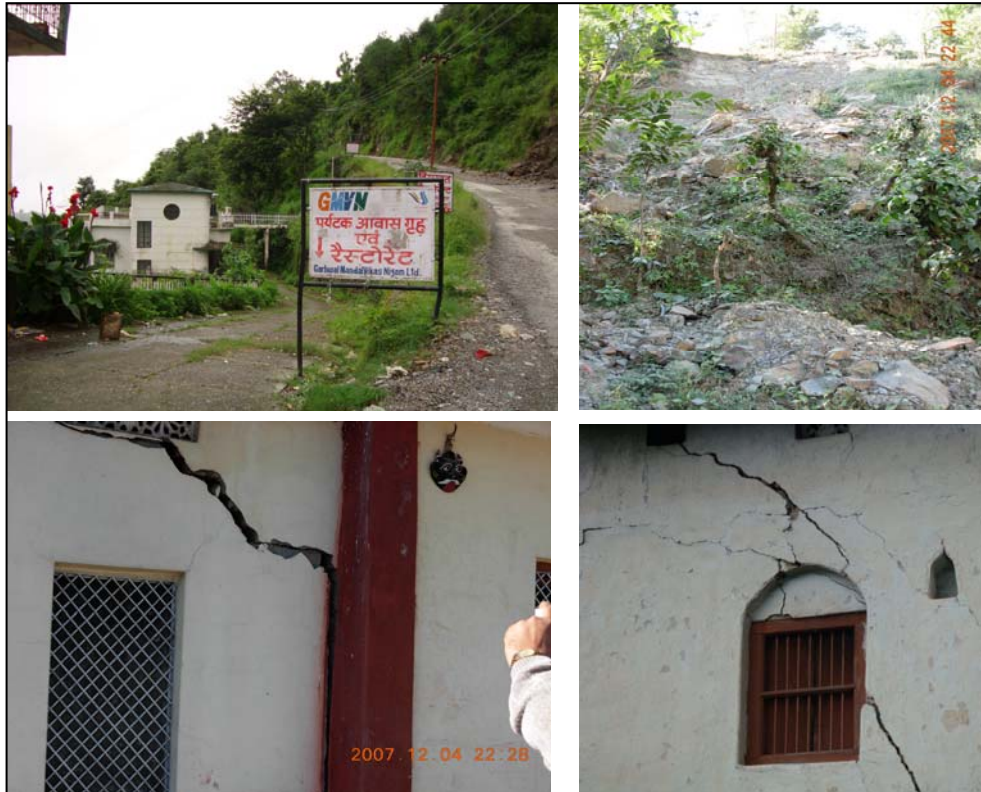
Slope instability in the area is evident by road subsidence and development of cracks in the houses situated on the downhill slope (Fig.2). Water seepage on the walls was noticed during the rains. There is a small slope failure

Figure 2 Indications of slope instability manifested by cracks in houses, road subsidence & slope failure

along the discontinuity plane. It was told by the residents of the houses that cracks on the walls get widened every year. All these field observation have indicated that the slope is presently unstable.

- Topography and soil cover indicates presence of a old slide.
- The geological investigation has indicated presence of fractured & weathered rocks, underlying loose overburden material allowing easy seepage of water.
- The structural data shows presence of unfavourable discontinuity.
- The rain water in the catchment area percolating underground and developing pore pressure.

The risk elements in the area are few houses and the highway which are vulnerable to sliding activity. Few control measures such as surface drainage and retaining walls have been suggested to arrest the further damage to the houses. The area at present does not indicate a major landslide event to occur however, it can not be ruled out in case of heavy precipitation accompanied by seismic shocks.

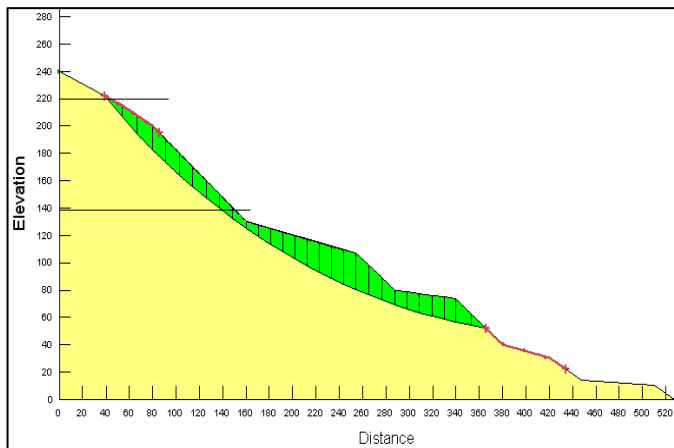
Laboratory investigation of soil samples was conducted. The soil comprises of gravel 34%, sand 35%, silt 29% and clay 2%. The cohesion varies between 0.02 -0.11  $\text{Kg/cm}^2$  and friction angle varies between  $40^\circ$  -  $46^\circ$ . The slope geometry obtained from the DEM and the friction and cohesion values were used for carrying out the slope stability analysis. Factor of safety obtained from stability analysis using the Slope/W software (Fig.4) under static condition shows that the slope is stable under dry condition (Factor of safety 1.4) which drops down to 1.19 under partially saturated condition. Dynamic slope stability analysis was also carried out considering the seismic effects and the displacement was found to be only 3-4 cm under dry condition but under saturated condition displacement was quite significant (Ghosh et al 2010).

Figure 4 Slope profile and probable slip surface

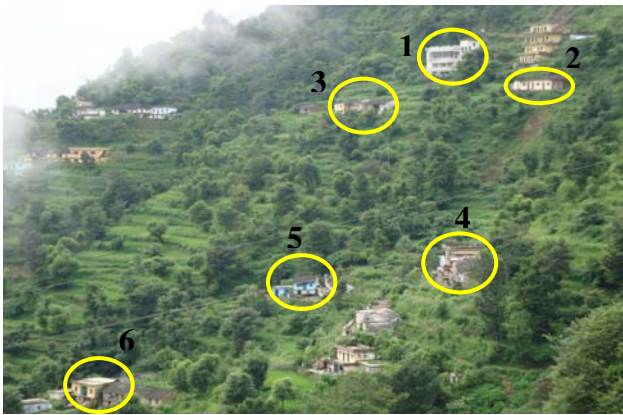
There are six houses on the slope which have shown distress manifested by development of cracks on the walls and floor subsidence. A monitoring scheme was planned to monitor the horizontal and vertical movements of these houses using Total station from a far distance outside the unstable zone. The Total station is an electronic theodolite integrated with an electronic distance meter (EDM) to obtain sloping, horizontal and vertical distances from the instrument to a particular point. Electronic Distance Measurement technology uses a ground-based, high-precision survey instrument that emits infra red wave to measure the time the wave travels

(a) Houses being monitored (a) and position of Total Station and target (b)

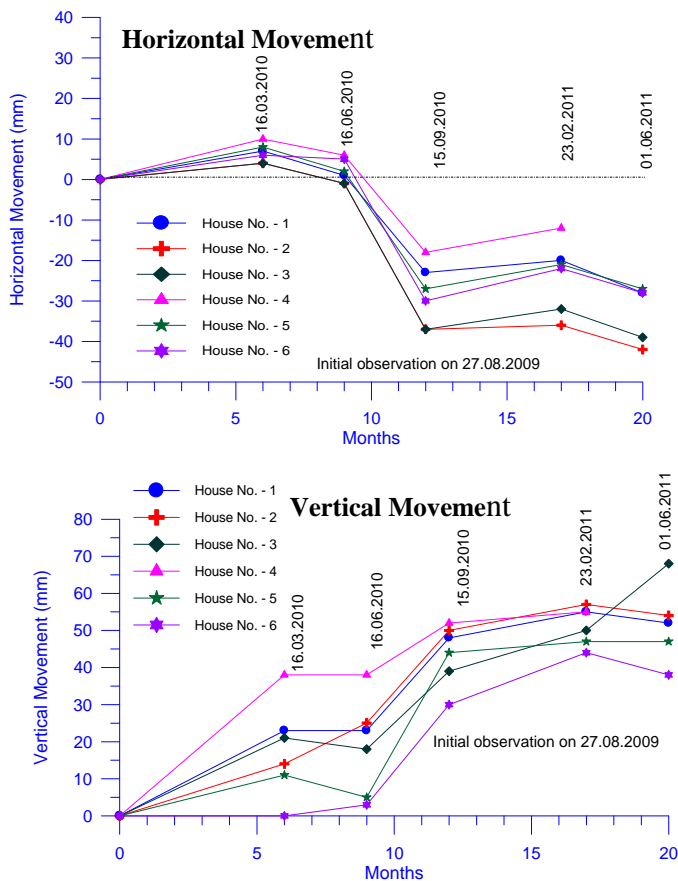
Figure 6 Horizontal and vertical movements

The observation points of the six houses show varied vertical and horizontal movements. In case of vertical movement, the house no 4 shows a vertical movement of 40 mm from August 2009 to March 2010 while the house no 6 shows negligible vertical movement during that period. There is no considerable movement during March 2010 to June 2010. A considerable movement varying from 15 mm to 35 mm is shown by all the houses during June 2010 to September 2010. The movement data when compared with the rainfall data (Fig. 7), it was found that the sudden increase of vertical movement during June to September 2010 can be well explained by the heavy rainfall during that period. During September 2010 to February 2011 there is not much movement. However, it can be inferred from the figure that all the houses have shown movements of a similar trend.

When considering the horizontal movement the total maximum movement of 40 mm during the total monitoring period is shown by the house no 2. The house no 4 has shown the least horizontal movement of 18 mm. In this case also maximum movement was observed during the heavy rainfall period of June 2010 to September 2010. Hence, the movement monitoring data

of the last two years has shown a cumulative vertical movement of 38-68 mm and cumulative horizontal movement of 20 to 40 mm. The monitoring study is being continued to assess the vulnerability of these houses against the slope instability.
