## **STABILITY ASSESSMENT AND SUGGESTION FOR CONTROL MEASURES OF A POTENTIAL LANDSLIDE SLOPE ON NH 94, UTTARAKHAND HIMALAYA, INDIA**

**A. Ghosh**

Central Building Research Institute (CSIR)  
Roorkee, Uttarakhand, India

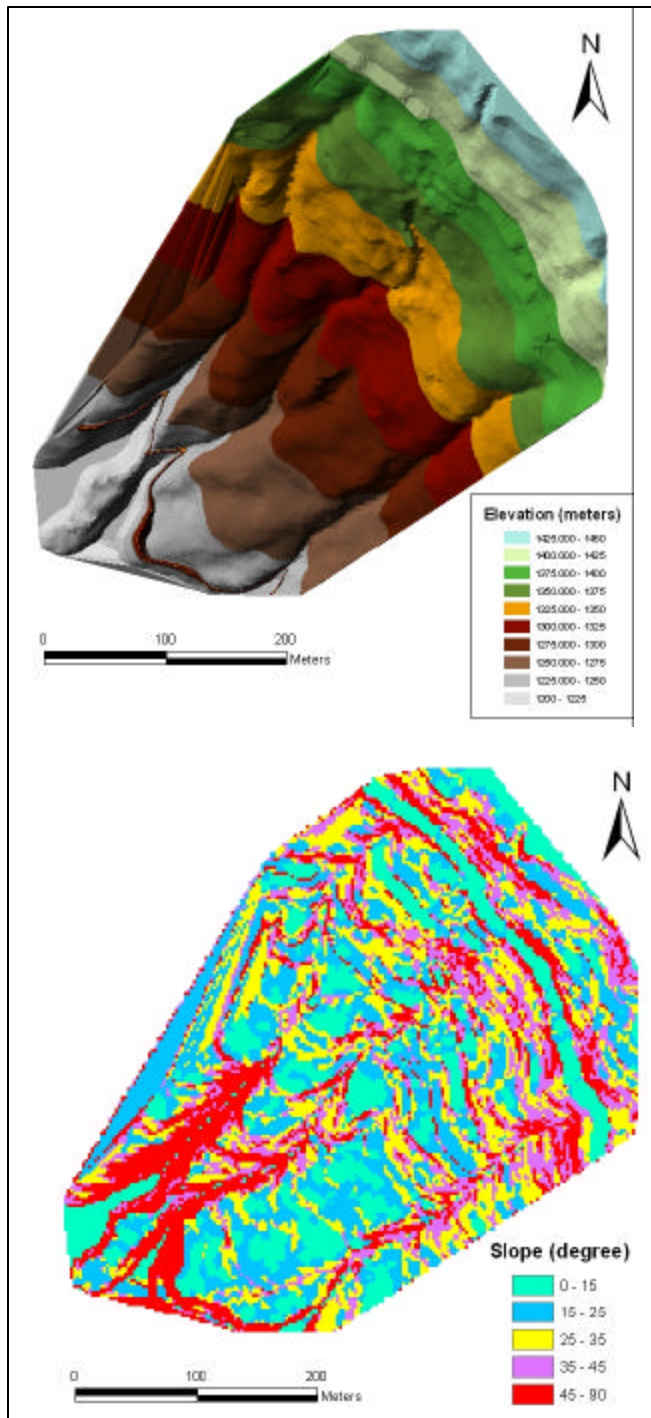
Fig. 2. Digital elevation model and slope map

A contour map was prepared on 1:1,000 scale with 2 meter contour interval. From the contour map digital elevation model and slope map were generated in GIS (Figure 2). The local relief of the area under study ranges from 1200 m to 1420 m from MSL. The slope map was classified into five classes. It can be seen from the slope map that the study area is mostly having 0-15° and 15-25° classes. The steep slopes more than 45° are the slopes along the drainage channels.

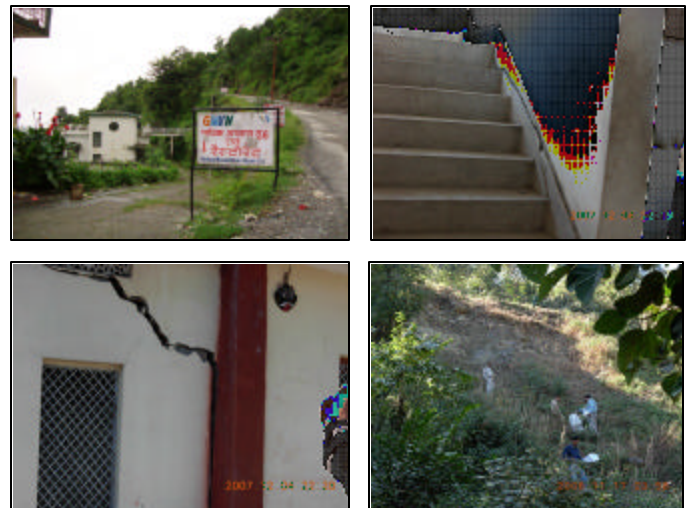
Slope instability in the area is manifested by road subsidence and continuous development of cracks in the houses situated on the slope. A tourist guest house located just below the road has developed major cracks and presently abandoned. The other houses situated on down hill slope have also developed cracks on the walls (Figure 3). Water seepage on the walls was noticed during the rains. There is a local slope failure along the joint plane comprising of rock pieces and loose debris. All these field observation have indicated that the slope is unstable.

Fig. 3. Damaged houses and local slope failure

The morphological expression of the slope and the slope material comprising mainly of gravels and sand indicate that the area is probably a very old slide zone. However, no historical data is available for confirmation. A detailed field investigation has shown that the prime cause of the slope instability is due to underground water seepage. The sub-surface water flow during heavy rains is causing subsidence at various locations resulting into development of cracks in the houses. However, source of underground channel leading to such subsidence is not completely understood.

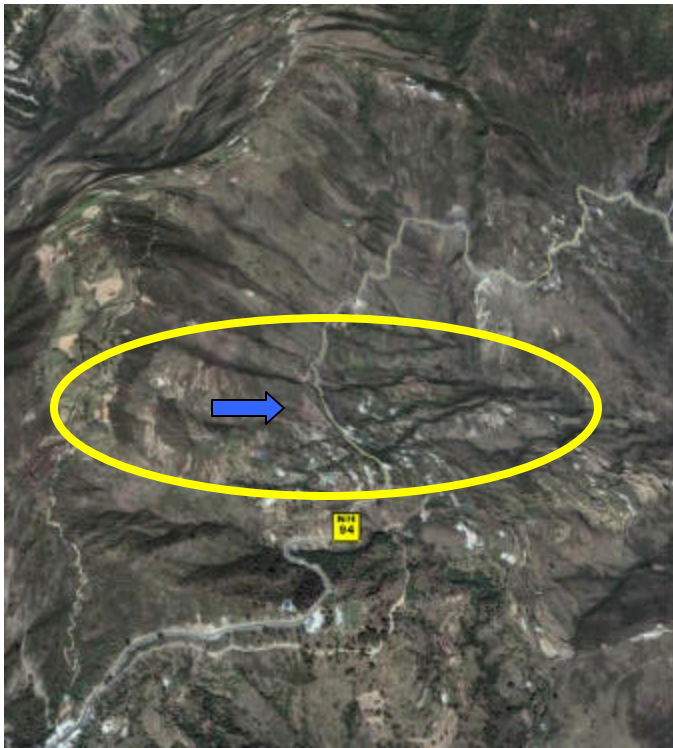
A regional topography of the catchment area of the slope can be very well seen from the Google image (Figure 4). From this image it may be inferred that a part of the rainfall received by the catchment in the uphill slope bounded by two drains infiltrates into the ground. Further, the central drain above the road disappears for a certain distance below the road and again reappears on downhill slope. Hence it may be inferred that the rain water in the central drain flow underground below road level and probably a source of water seepage in the area.

To confirm this geophysical resistivity survey was conducted at road level. The analysis of the data suggests that the resistivity values are very low at 9 m depth indicating a weathered rock and or wet strata. This partly strengthen the

fact that there must be a hidden water channel below the road which allows water to saturate the sub-surface strata and develop pore pressure leading to slope instability. The dissipation of pore pressure during lean period is a likely cause of road subsidence.

Fig. 4. Regional topography in Google image

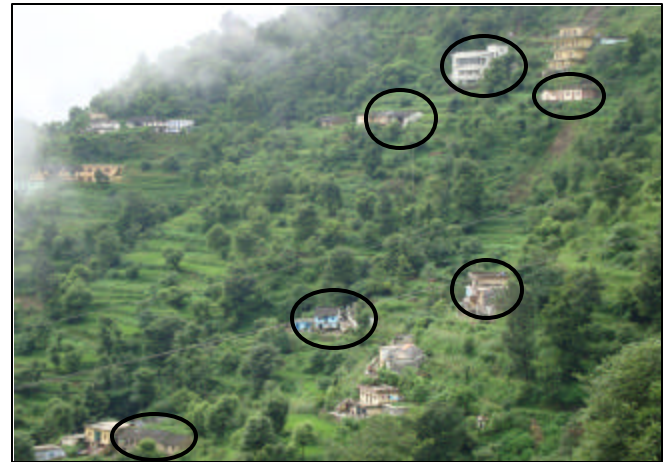
It was felt necessary to monitor the cracks in the houses and also movement of the houses to estimate the degree of sliding activity (Figure 5). For this cracks in the six houses are being monitored using simple devices. So far no significant

movement was recorded for the last one year. All these six houses are also being monitored for their horizontal and vertical movement from a stable point using Total Station. An automatic rain gauge has been installed in the area to monitor the daily rainfall. The rainfall data (Figure 6) of August and September 2009 has not shown any major event which substantiates the fact that no significant crack widening was observed in this year. The monitoring study is being continued.

Fig. 5. Houses on the slope which are being monitored
