D. P. Sen Gupta,  
B. Dey  
D. Roy

INDIAN GEOTECHNICAL JOURNAL

# Sub-strata Treatment for A Building Using Rope Drains

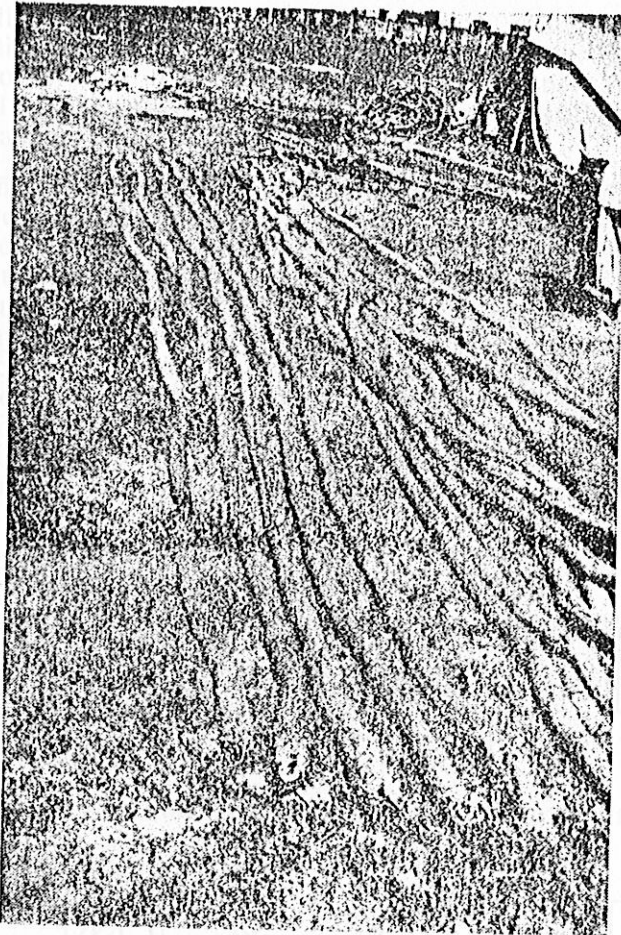
FIGURE 1b Prepared drains rope

Rope drains have been developed by the Central Building Research Institute to function as vertical drainage paths for pre consolidation of compressible soil strata. The flexible rope drains having 70 mm outer dia are made by rolling long strips of 150 mm wide, 10 mm thick coir mat (Figure 1a and Figure 1b). The cylindrical drain with continuous drainage path along its length showed very high permeability and the soil in contact would not penetrate inside to choke the drainage efficiency. History of its development and success of its performance in the field have already been reported.

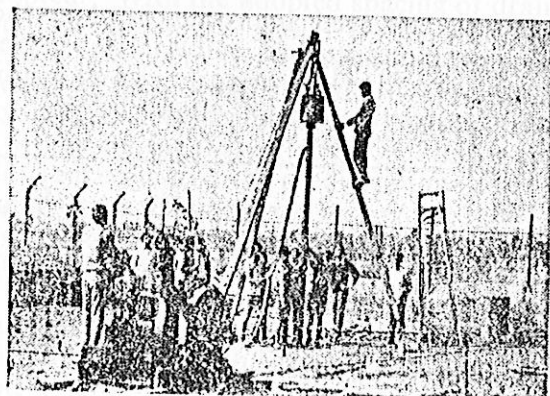
FIGURE 4 Driving operation for installation of rope drains.

The drains were installed by driving steel casing pipes with the rope drain inside. The drain was securely tied with the detachable steel conical shoe closing the bottom of the steel casing pipe. To make use of simple equipment and to eliminate high driving rigs, the steel casing pipes were in 3 m lengths, which could be connected to one another with proceed of

penetration. The special driving head used for receiving the hammer blows was provided with a window at the side. Through the window the extra length of the rope drains protruding out of the casing pipes could hang and did not receive any hammer blow. The driving was done by blows from a 500 kg. drop hammer operated by a diesel-power driven winch. The simple appliances are shown in Figure 4 on reaching the desired depth of 10 m, the casing pipes were withdrawn leaving the rope drains embedded into the ground. It was possible to install 6 drains in a day of 8 working hours.
