**Proc. Structural Engineers Congress(SEC-2008),
Chennai, Dec. 18-20, pp. 1227-1236**

DETERIORATION AND REPAIR OF CONCRETE STRUCTURES IN THERMAL POWER PLANTS

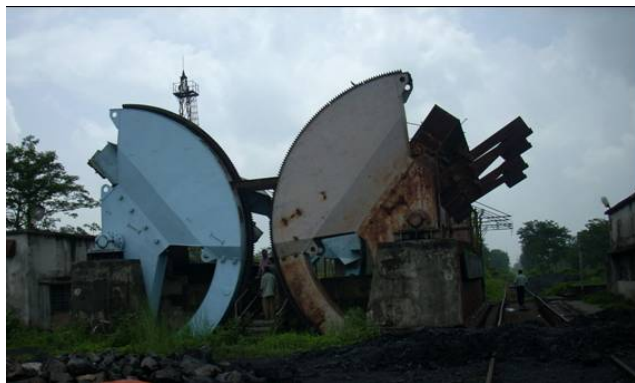
Figure 1 A wagon tippler used for unloading coal from the wagons.

In CHP the design of coal unloading system depends on the location of the coal source and mode of transportation. Railway is the dominant mode for the plants far away from the coal mines. Generally there are two types of coal unloading systems in use: Merry-Go-Round (MGR) and Wagon Tippler. In MGR system the coal is unloaded from wagons with bottom doors, which are pneumatically operated. Coal from the wagons is unloaded in the underground track hoppers and then sent to crusher house with the help of conveyors. In wagon tippler type system (Fig. 1) coal is unloaded by tilting the wagons with help of wagon tippler into the wagon tippler hopper and then fed to the crusher house with the help of inclined belt conveyors.

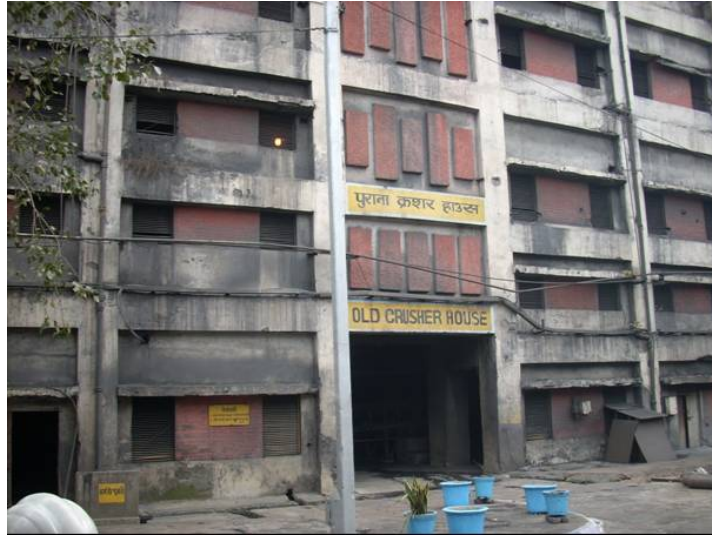
Figure 2 A crusher house building

The structures in a CHP include unloading hoppers, reclaim hoppers, inclined belt conveyors, transfer towers, vibrating screens, magnetic separators, crushers, weighing machine, silos and dust collecting system. Crusher house (Fig. 2) is a building, which houses roller screens and coal crushers. Thus, it is subjected to mechanical vibrations and exposure to coal dust. Most of the conveyor belt support structures are made of steel with the columns standing on concrete foundations. The concrete is damaged mechanically mostly by impact of various objects and vibrations. In general, CHP structures are exposed to dusty, dirty and often wet conditions. They are also sometimes exposed to accidental fire in the coal. The signs of deterioration observed in these structures are structural cracking, concrete spalling and reinforcement corrosion.

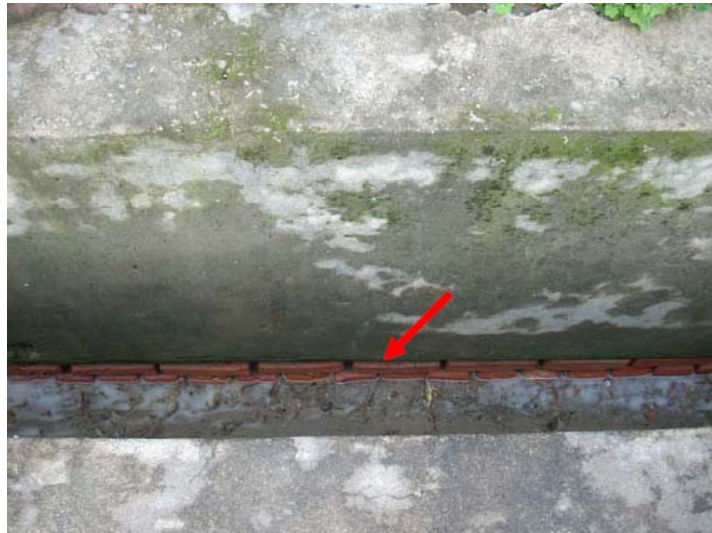
Figure 3 Erosion of plaster in effluent drains

The water system in thermal power plants includes the pre-treatment and clarification plant, demineralisation (DM) plant, cooling towers and effluent treatment system. DM plant is used for supplying clean and soft water to boilers for steam production. The water produced contains negligible impurities and ensures a longer life and better efficiency of the boilers and their components. This plant uses ion-exchange processes for water treatment. In this process, for the regeneration of the ion exchange beds carried out using strong acids and bases. These chemicals are very aggressive to the linings and other construction materials (Fig. 3). A concrete column exposed to such condition is shown in Fig 4.

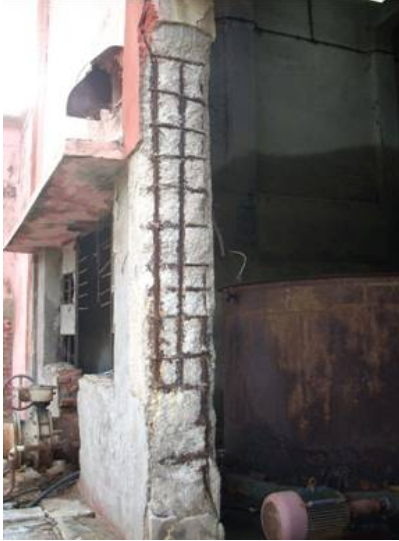
Figure 4 A column showing extreme deterioration due to corrosion in a DM Plant

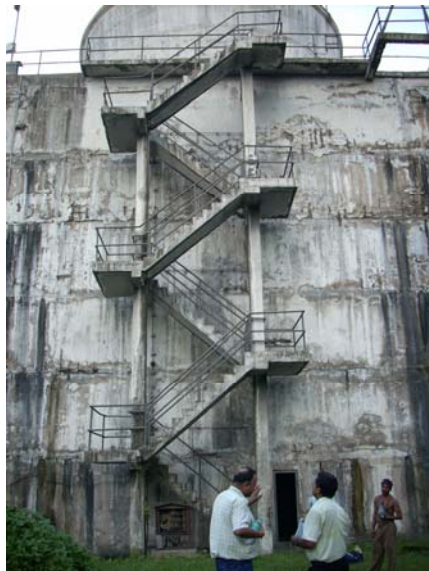
Figure 5 A deteriorated wall of cooling tower.

The hot and humid condition in cooling towers deteriorate concrete elements leading to cracking, delamination and spalling (Fig. 5 & 6). The vapours provide moisture for the corrosion of the embedded steel reinforcement particularly in higher and outer parts of concrete shells in the cooling towers.

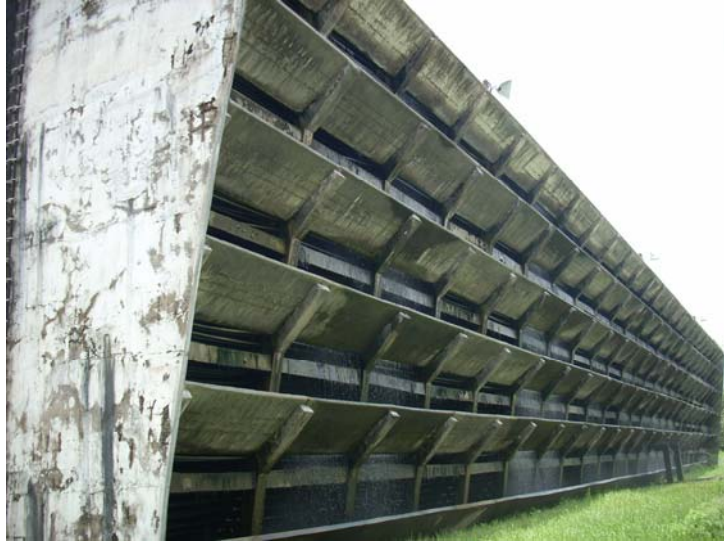
Figure 6 Another view of the cooling tower.

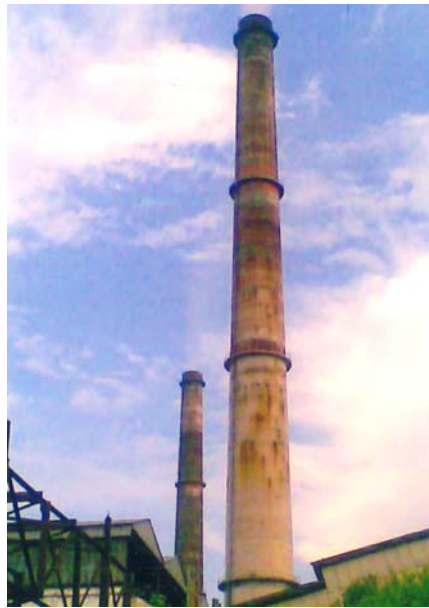
Figure 7 Deterioration of outer surface of concrete chimney

Chimneys in the coal-fired power plants generally have an outer shell made of reinforced concrete and an internal fire resistant lining system, which protects the inner surface of concrete shell from high temperature and protect it from chemical attack by acidic components of flue gases. Imperfect and damaged lining of the chimney allows the inner surface of the concrete shell to expose to flue gases, high temperature, humidity fluctuations, and eventual moisture condensation. The corrosion in the concrete in such environment is mainly due to chemical reactions of carbon dioxide, sulphur dioxide and trioxide, nitrogen oxides and vapour with the products of cement hydration producing calcium carbonate and sulphur-bearing compounds (Pavlik et al., 2007). The deterioration in concrete shell increases with the height (Fig 7). Some of the commonly observed symptoms of deterioration are stains, cracking and spalling of concrete. This enhances the exposure of concrete shell and further deterioration takes place. The platforms at different heights are also damaged and finally dropped due to misplacement and/or corrosion of reinforcement (Fig. 8).

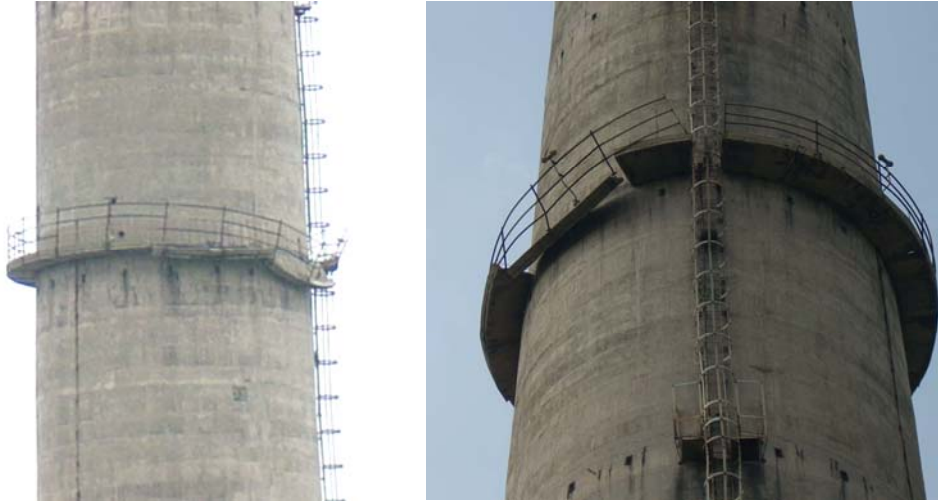
Figure 8 Damaged platforms of the chimney

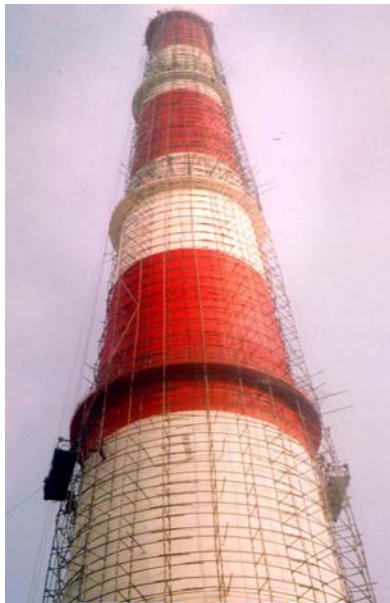
Figure 9 A chimney after repair and coating

The repair materials i.e. bonding agent, polymer modified mortar and coatings developed by CBRI have been used in the field for the repair and protection of concrete structures in thermal power plants like NTPC, Badarpur (Fig. 9) and in Kutch (Gujrat). The properties of cardanol epoxy coating used in chimney in NTPC Badarpur have been compared with those of epoxy based coating in Table 2 (Aggarwal et al. 2007c). The coatings developed by CBRI have been applied on some important commercial buildings, flyovers and railway bridges including the MTP Railway Bridge in Chennai. Besides these, corrosion resistant coatings developed by CBRI have been used to coat reinforcement steel in number of structures throughout India.

1. Removal of the disintegrated/ loose concrete and cleaning of the concrete surface and exposed reinforcing bars.
2. Application of a corrosion inhibiting coat, which may be comprised of a corrosion inhibitor or migrating corrosion inhibitor and coating on reinforcement.
3. Bond coat of a polymer modified cementitious material or an epoxy-cardanol coating.
4. Application of patching materials made of polymer modified cementitious mortar based on epoxy latex/acrylic or epoxy mortar.
5. Surface protective coatings using one of the coating systems like those based on epoxy- cardanol resin.
