### Landslide disaster of 24 September 2003 in Uttarkashi

*A landslide disaster occurred in Uttarkashi on 24 September 2003 which has affected a part of the town. The paper highlights the probable causes of the slide, degree of instability in the Varunavat hill and risk assessment. According to an earlier assessment some instability was persisting in the Varunavat Parvat which triggered the slide after a heavy rainfall. The earlier landslide scars and cracks present prior to the slide contributed to the instability in the hill. The potential zone of risk in the foothill had been assessed and suggestions were made to administrative authorities to minimize loss of life and property.*

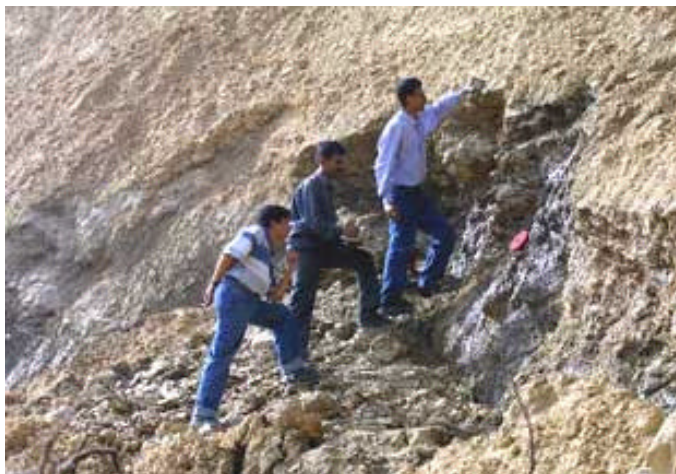
Figure 3. Pulverized material and water seepage at slip surface.

the crown was measured to be 60–70 m. The length of the slide surface on the upslope was more than 100 m. The exposed slip surface was dipping southwardly with 40° dip. The scarp was covered with pulverized clay along with scanty rock outcrops (Figure 3). The area is extremely unstable due to the presence of several cracks, some of which are more than a metre deep. Most of the cracks are transverse, while there are some longitudinal cracks also. Beyond the present limit of the sliding mass, it was found that there are a few cracks on the right flank, indicating possibility of widening of the landslide.

The landslide activity can be minimized by implementing adequate remedial measures. These include sealing of cracks, slope-grading, construction of retaining walls, proper drainage measures, soil re-

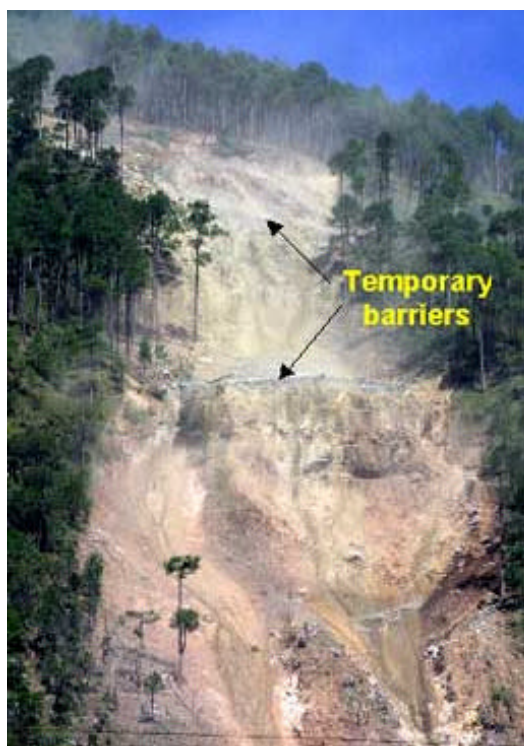
Figure 4. Main channel of debris flow.

After surveying the slide area on 30 September, it was found that about 40,000–50,000 m<sup>3</sup> of slide debris was lying on the upslope. There was continuous movement of the debris along the downhill slope, which got finally deposited on the accumulation zone at the road level. On the uphill slope a few large boulders and uprooted trees had made a temporary barrier (Figure 4) across the main channel of debris flow, due to which a new channel had opened up on the right flank. In the downhill slope of this new channel, the debris was accumulated on a gentle slope which was temporarily supported by the uprooted trees and dense vegetation. It was assessed at that time that the debris along this channel could further destroy some part of the town. In view of this, evacuation of a few localities had been advised by the district administration.

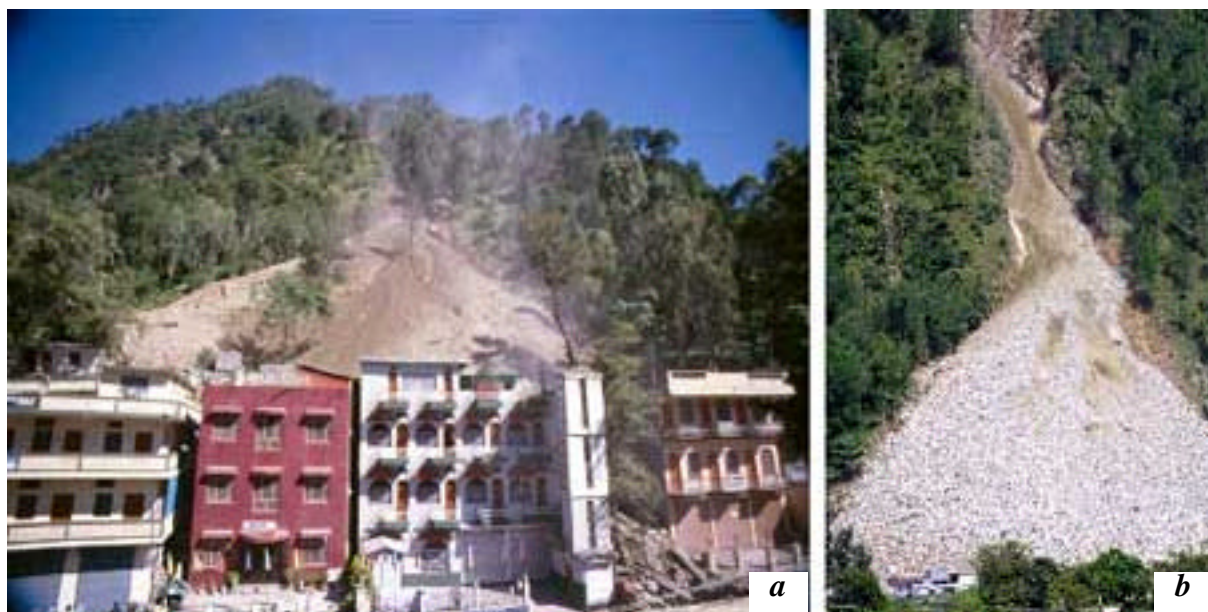
**Figure 5.** Buildings standing after two days of sliding (a) and buried under debris later (b). (Figure 5 a courtesy Roopsagar Studio, Uttarkashi.)

aged. Recently constructed hotels and tourist lodges, which existed even after the landslide was triggered, were completely buried later under the debris (Figure 5). The debris has also buried the Uttarakashi–Gangotri National Highway-108, affecting about a kilometre stretch. It was reported by the district administration that about 362 dwelling houses were completely ruined by this landslide. However, it was fortunate that there were no casualties, as the district administration took prompt action to evacuate fami-

sidering the risk, evacuation of buildings and habitation which may be affected by the sliding debris, was advised. On our next visit to the site (23 October), it was observed that the sliding activity had started in the anticipated zone of risk. Hence, the suggested evacuation plan had helped in minimizing property damage without any loss of life. After assessing the instability in the area, it was inferred that the foothill slope of the Varunavat Parvat between the Tambakhani slide and the newly developed landslide scarp, is a potential zone of risks. Hence, it is not advisable to rehabilitate this landslide-affected zone till the slope is stabilized.
