SLOPE INSTABILITY AND RISK ASSESSMENT OF AN UNSTABLE SLOPE AT AGRAKHAL, UTTARAKHAND

ABSTRACT: Slope instability problems at Agrakhal on Rishikesh-Uttarkashi-Gangotri National Highway of Uttarakhand State has induced distress in many houses situated on the slope. Geological and geotechnical investigations were carried out to assess the slope instability and risk assessment. Topographic survey of the slope was carried out and a contour map was prepared for topographic analysis. Geologically the rocks present in the area are highly weathered phyllites. The outward dipping discontinuity in the rocks favour slope instability. From the field investigation it is inferred that continuous water flow in a drain and water seepage at various locations are the main contributing factors for the instability. Soil samples were collected and tested in the laboratory for their geotechnical engineering properties. The paper presents the details of site investigation and slope stability analysis and risk assessment.

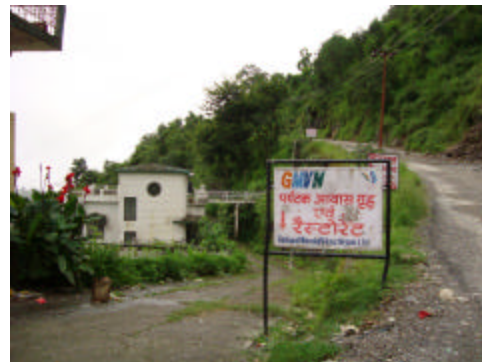
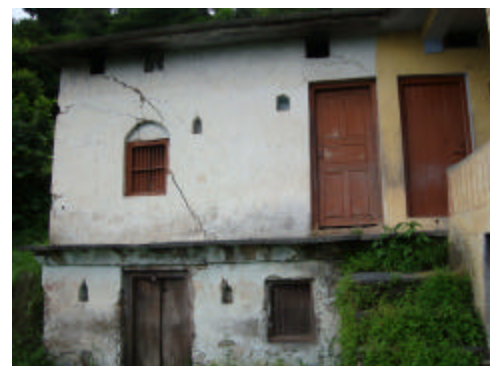
Slope instability of the area is indicated by the road subsidence at upper level and by the distress observed in the houses situated on down hill slope. There are several cracks in many houses situated on the slope (Fig. 2). It is informed by the house owners that these cracks get widened during rains. Water seepage was noticed on the walls of the houses during rain.

Figure 2 Road subsidence & damaged houses

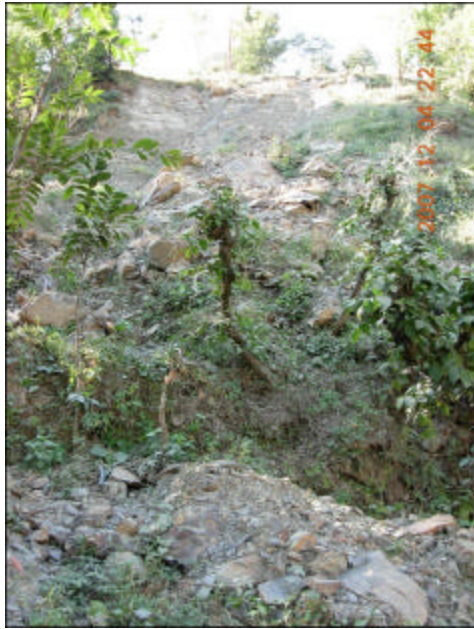
A small slope failure was also noticed along joint plane. The slid debris is mostly fragmented rock pieces with soil (Fig. 3).

Figure 3. A small landslide on down hill slope

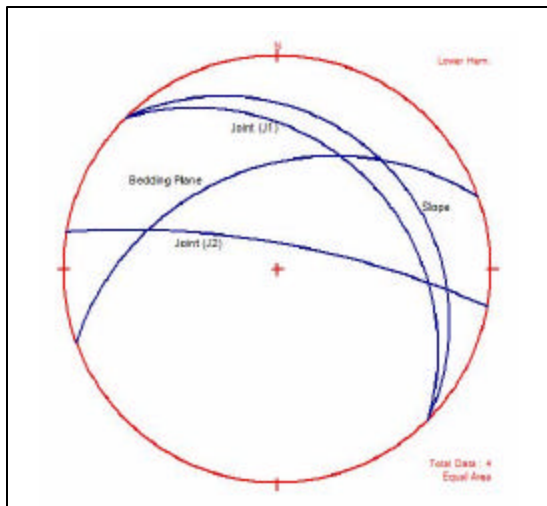
The geological data was collected to prepare the geological map of the area. Rocks present in the area are Phyllites, which are highly weathered, fractured and thinly bedded. The rock beds dip 50° towards NW and there are two major joint sets, out of which one joint dipping towards NE is outward dipping favouring slope instability (Fig. 4). The soil cover on the slope is about 2-5 m thick. There are three major drains on the slope. The houses situated on either side of the central drain have shown sign of distress. From the field investigation it is inferred that continuous water flow in the central drain is contributing slope instability in the area. The sub-surface water seepage particularly during rains is causing slow failure at few locations resulting in development of cracks in houses.

Figure 4. Stereographic analysis of structural data

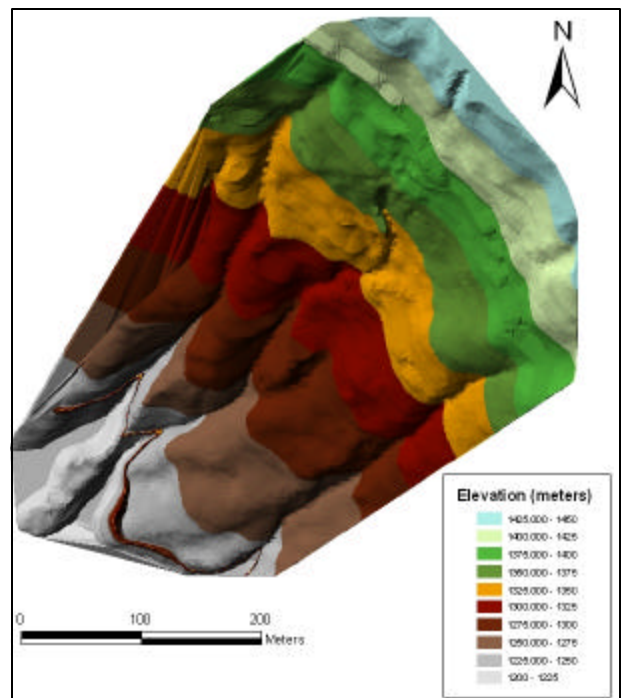
Topographic survey of the slope was carried out and a contour map was prepared on 1:1,000 scale with 2 meter contour interval (Fig. 5). The contours were digitized and a Digital Elevation Model (DEM) was generated in using Arc GIS (Fig. 6). A slope map was also derived from the DEM to see the distribution of slope amounts in the area. Several slope profiles were prepared from the DEM which were used for slope stability analysis.

Figure 6. DEM of the slope

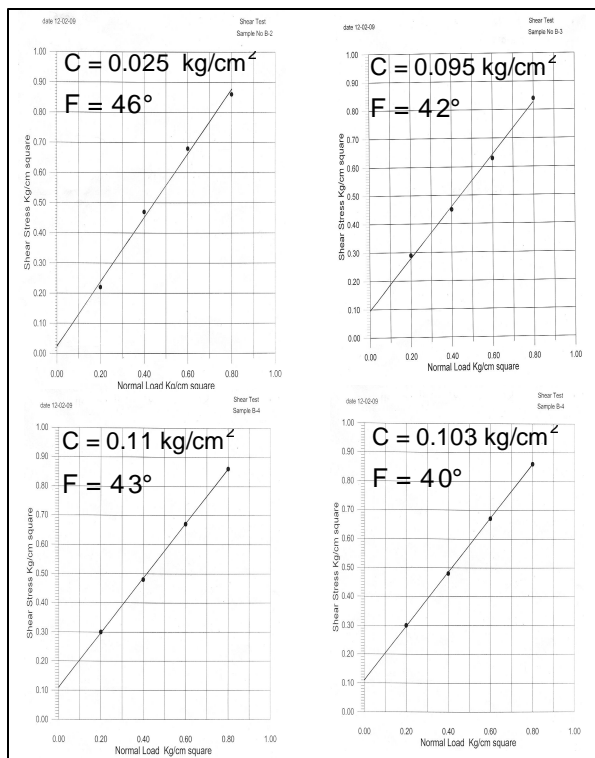
Grain Size: Gravel 34%, Sand 35%, Silt 29%, Clay 2%
 O.M. C. 18%
 Proctor density: 1.74 gm/cc
 Cohesion: 0.02 - 0.11 Kg/cm²
 Friction angle: 40 - 46°

Results of few shear tests are shown in the Figure7.

Figure 7. Shear test results

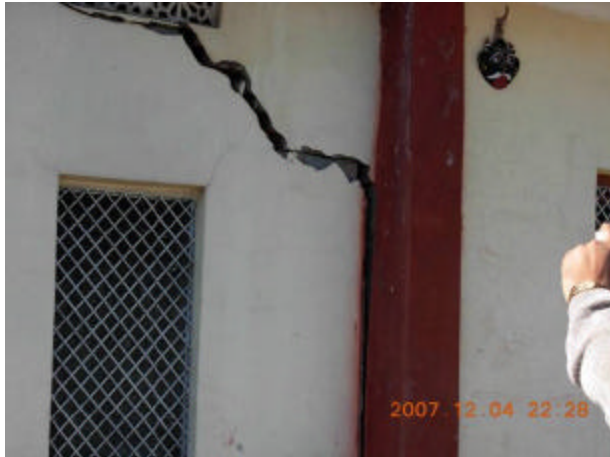
Factor of safety computed from stability analysis shows that the slope is unstable under saturated condition. There are many houses situated on the slope which have already shown distress. Some houses have been cracked so much that the occupants perform have to vacate the house (Fig. 8).

Figure 8. A major crack in one of the houses

From the present investigation it has been inferred that the multiple cracks developed in the houses are continuously widening. Cracks are being monitored periodically. Though some of the houses have been vacated and the GMVN guest house has been abandoned, there are many houses where peoples are still leaving. This is because they have their agricultural land on this slope. Except agricultural land and few houses there is no other infrastructures which could be assessed under economic loss due to any future event. Since there is not much ground movement observed on the slope, the risk is not very high. However, the people living there should be educated properly so that they can monitor the cracks and other indications of instability and alert themselves before any major event.

- V. The associated risk in the area is few houses with their inhabitants. Though the area at present does not show any indications of disaster but to be more specific about the degree of distress, few cracks in the houses are being monitored through instrumentation. Further studies are being carried out to suggest adequate remedial measures to stabilize the slope and protect the houses.
