LANDSLIDE INVESTIGATION AT PHATA VILLAGE ON RUDRAPRAYAG- KEDARNATH ROAD, UTTARANCHAL - A CASE STUDY

A.Ghosh

Geotechnical Engineering Division
Central Building Research Institute
Roorkee-247667 (INDIA)

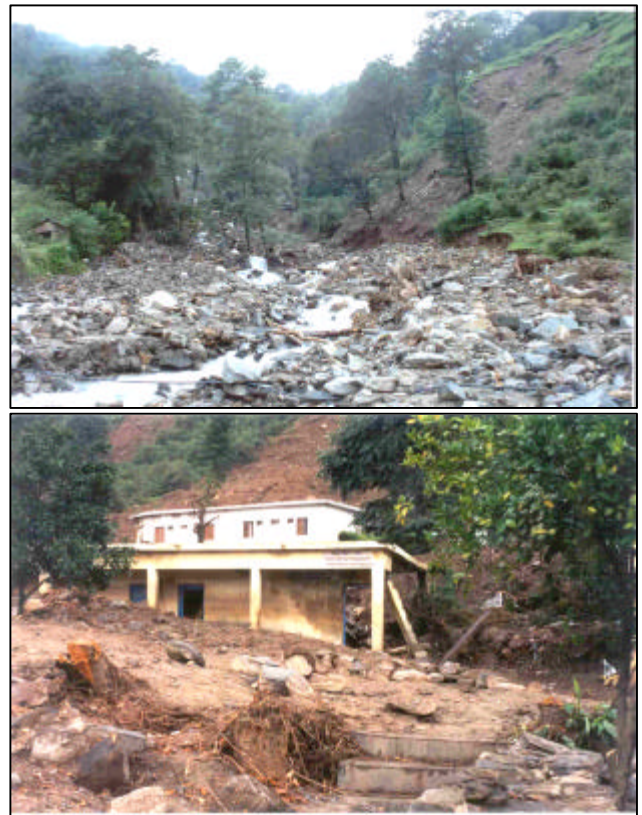
Fig. 1. Debris flow at Phata village in 2001

The landslide claimed 15 lives and buried several houses and vehicles under the debris (Fig. 1). In this area the rocks are mostly schists and gneisses which have been subjected to intense shearing and fracturing by numerous faults besides the major thrust the Main Central Thrust MCT. The weak geological formations are severely eroded by numerous streams and there exist numerous springs which also add the erosional process and sometimes play a major role for landslide occurrence (Sarkar et al., 2001).

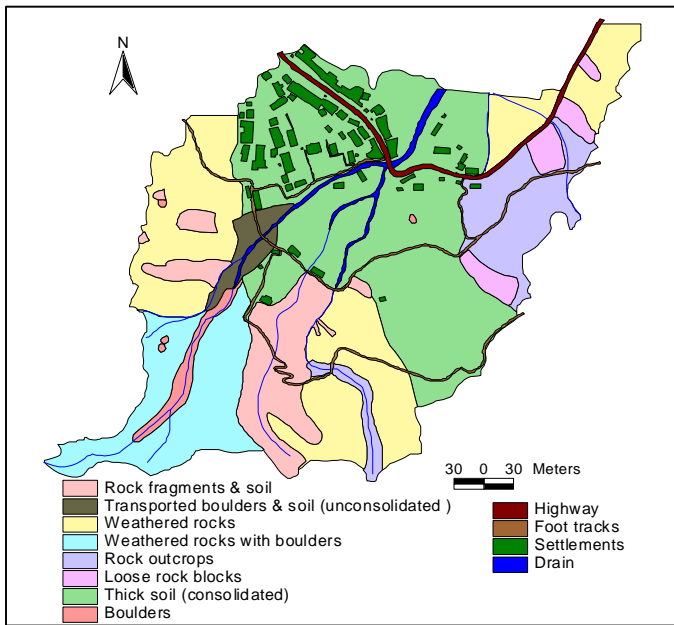
Fig. 2. Engineering geological map of the Phata landslide

Phata village is situated at an altitude of 1500m from the MSL on the Guptkashi – Gaurikund road sector on way to Kedarnath shrine (Lat: 30°34.601'N and Long: 79° 02.413'E). Two major drains are present, which are the main water sources in this area. Apart from these two drains, there are other channels on the slopes which are contributing debris to the main side. Height of the crest from the road level is 135 m. The central part of the slide is covered by mostly boulders, rock fragments and fine materials. There is a huge accumulation of large boulders along the main drain. Rocks are exposed on both the flanks and at the crown of the slide.

The main rocks exposed in the slide area are gneiss and mica schist. The foliation trend is 48° N 65°. The rocks are highly weathered along with two sets of joints. Tension cracks developed due to sliding are present on the right flank and near the crown of the slide. The cracks are of 20- 30 cm width and 20-25 m length. It was told by the villagers that the cracks are widening gradually. A large portion of the slope is presently being used for cultivation. Habitation and school building are also present on the down hill slope.

Topographic survey was carried out and a contour map on 1:1000 scales with 1m contour interval was prepared. From the contour map the DEM of the slope was constructed in GIS. The engineering geological map of the slide area and the DEM are shown in the Figs. 2 and 3 respectively.

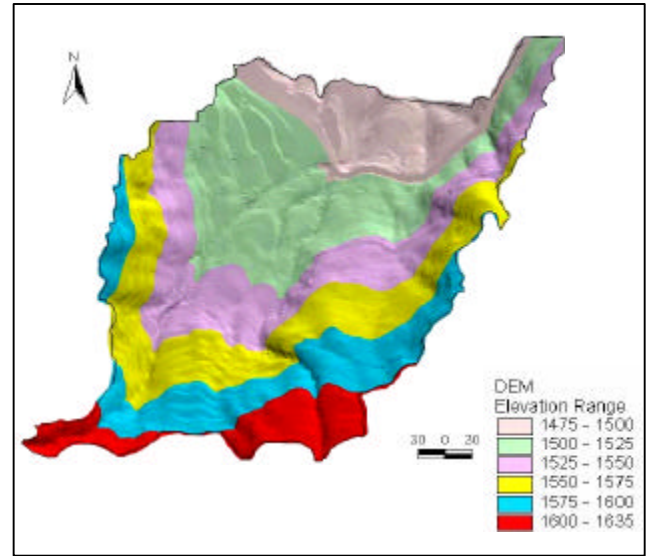
Fig. 3. DEM of the Phata landslide

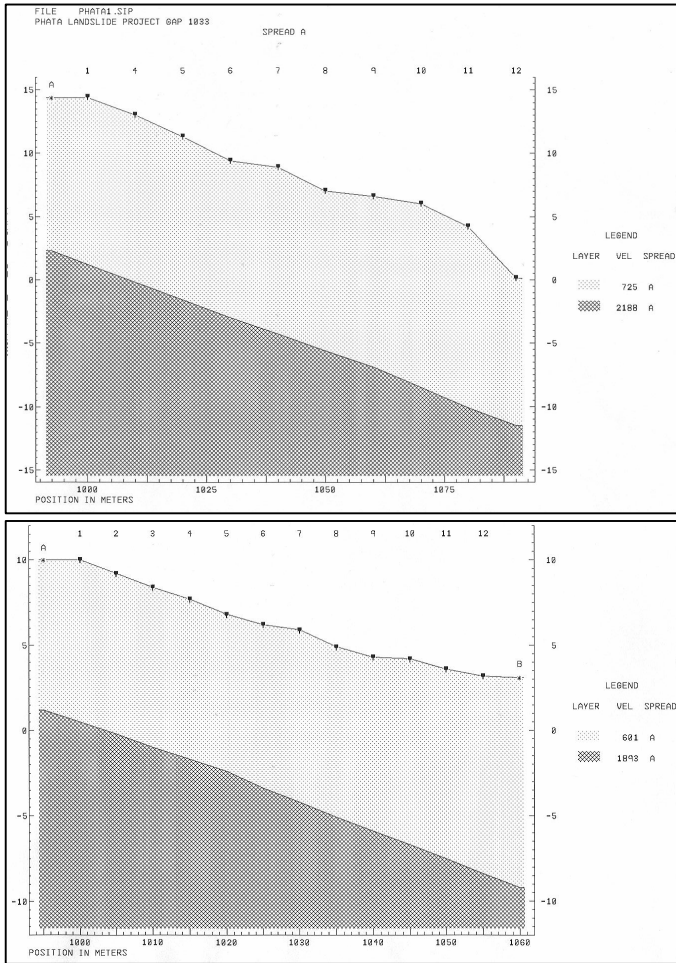
Fig. 4. Seismograms at two sections

carried out along two sections and on both sides of the drain. The first profile was taken laterally about 50m away on the right side of the drain and the second profile was taken just on the left side along the drain. 12 vertical geophones of 6 Hz frequency range were placed over a stretch of 100m to detect the refracted signals from the subsurface layers. Hammer blows were used as the source of energy.

The seismograms show two distinct layers (Fig. 4). The top layer composed of soil, boulder and rock fragments, which were transported from the higher altitude probably during the debris flow in the year 2001, has very low velocity of propagation. The next layer is the intact bed rock layer which has much higher velocity of propagation. Broadly it can be inferred from these seismograms that the overall thickness of the loose material in the middle of the slope ranges from 9 to 12m. This overburden material is susceptible to erosion under water flow. The contact layer of the loose debris material and the bed rock is the likely plane of failure under any triggering condition.

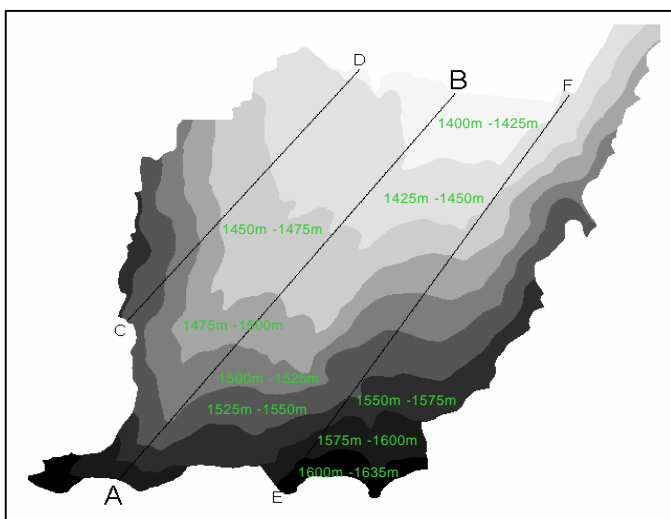
Fig. 5. Sections for stability analysis

In the present study stability analysis was computed along three sections AB, CD and EF (Fig. 5). The three profiles along these sections are shown in the Fig. 6. Both Limit Equilibrium and Seismic stability analysis were carried out for circular and planar modes of failures. The contact surface between the overburden and the bed rock was assumed as the surface of failure (as identified through the seismic survey).

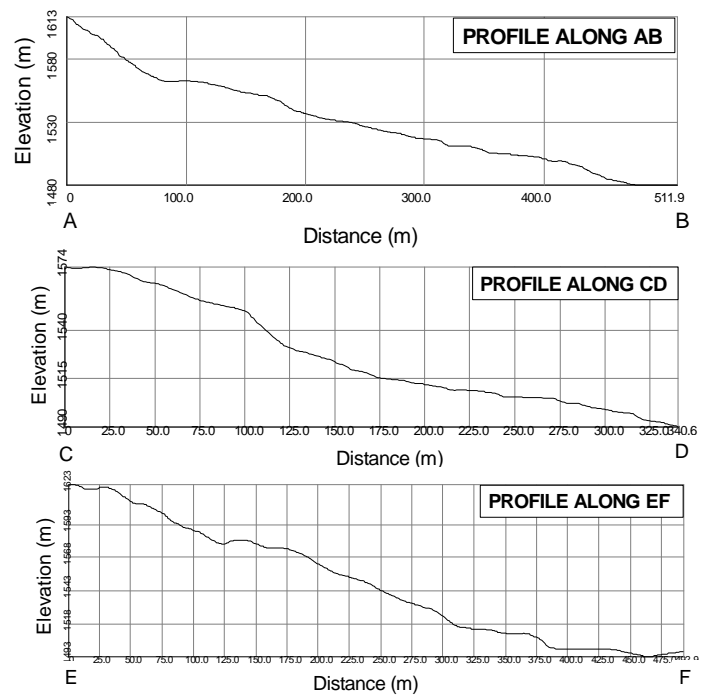
Fig. 6. Profiles along the sections AB, CD and EF

Results of Stability Analysis. The overall slope of the landslide is gentle ($15 - 20^\circ$) and the Factor of Safety under static condition without pore pressure was found to be 1.43. Factor of safety was also computed for the steep local slopes separately. The factor of safety for such steep slopes under static condition without pore pressure turns out to be around 1.2. Further with rise in pore pressure the factor of safety value turns out to be marginally more than unity ($FS = 1.035$) indicating the marginal stability of the slope. Hence it could be said that during heavy rains local slips are expected on these local steep portions of the slope. The material dislodged due to local slips may get deposited into the drain causing partially blockade of the flow. The slope material has considerable silts and the permeability was found to be of the order of 10^{-6} cm/sec. As a result due to heavy rain continued for couple of days it is expected that pore pressure on the slope may rise and could trigger the local slips.
