A GEOTECHNICAL CASE STUDY OF FOUNDATION PERFORMANCE OF A BUILDING IN HOT WATER SPRING AREA

Dovendra Sharma and G. S. Mohrotra

ABSTRACT

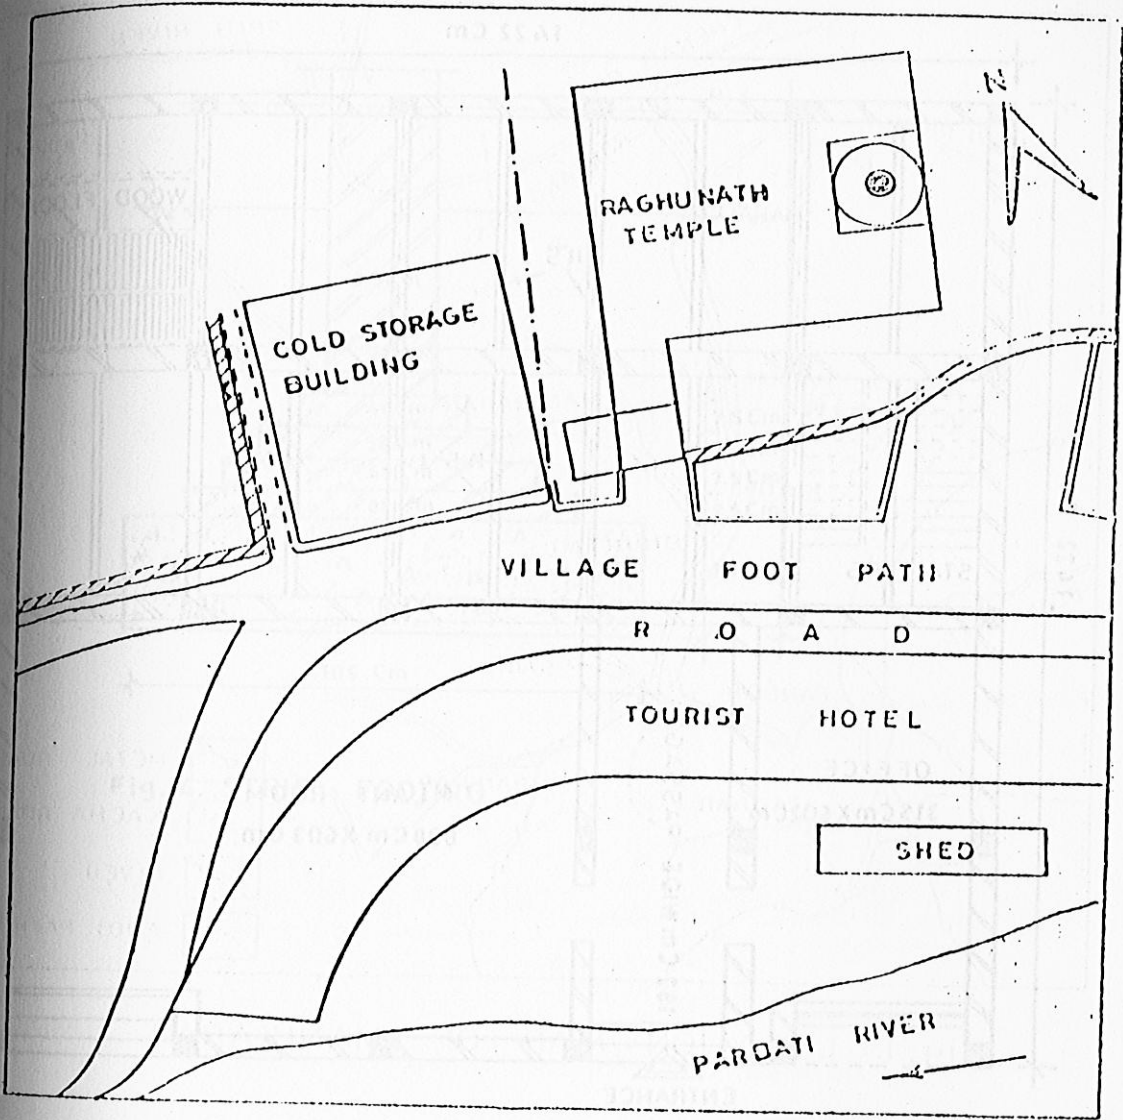
Fig. 2. KEY PLAN

The river course at the Manikaran is approximately east to west and the whole village is situated on a terrace at the all foothill (Fig. 2). The cold store building is in the vicinity of Sri Ram Temple. The building is 14.22mx14.22m in plan (Fig. 3) having the office room and the Plant Room in the front portion with a covered passage in between the two leading to the Cold Storage area. The walls are of one-and-a-half brick thick, with 35cm thick plaster inside and exposed brick work in the exterior. The maximum height of the cold storage side walls is 9.33m while the front portion is about half of this height. The walls have 38cmx23cm RCC columns in the brick walls to support the loads of the stored materials and the roof trusses with A. C. Sheets. There is three tier storage space having a clear headroom of 2.25m. The intermediate floors are of RSJs and wooden jafri. The finished floor level was in the front portion at 45 cm above the ground level. To accommodate the air space and RSJs etc. The floor level in the store is about 18cm lower than the ground level. Under the floor the filling was done by the local coarse sand and it had the usual specifications of 38mm top concrete finish over 76mm lean concrete. However, in store room floor, instead of lean concrete, the concrete as in top was used. The actual ground level was only a few cm below the floor level of the plant room.

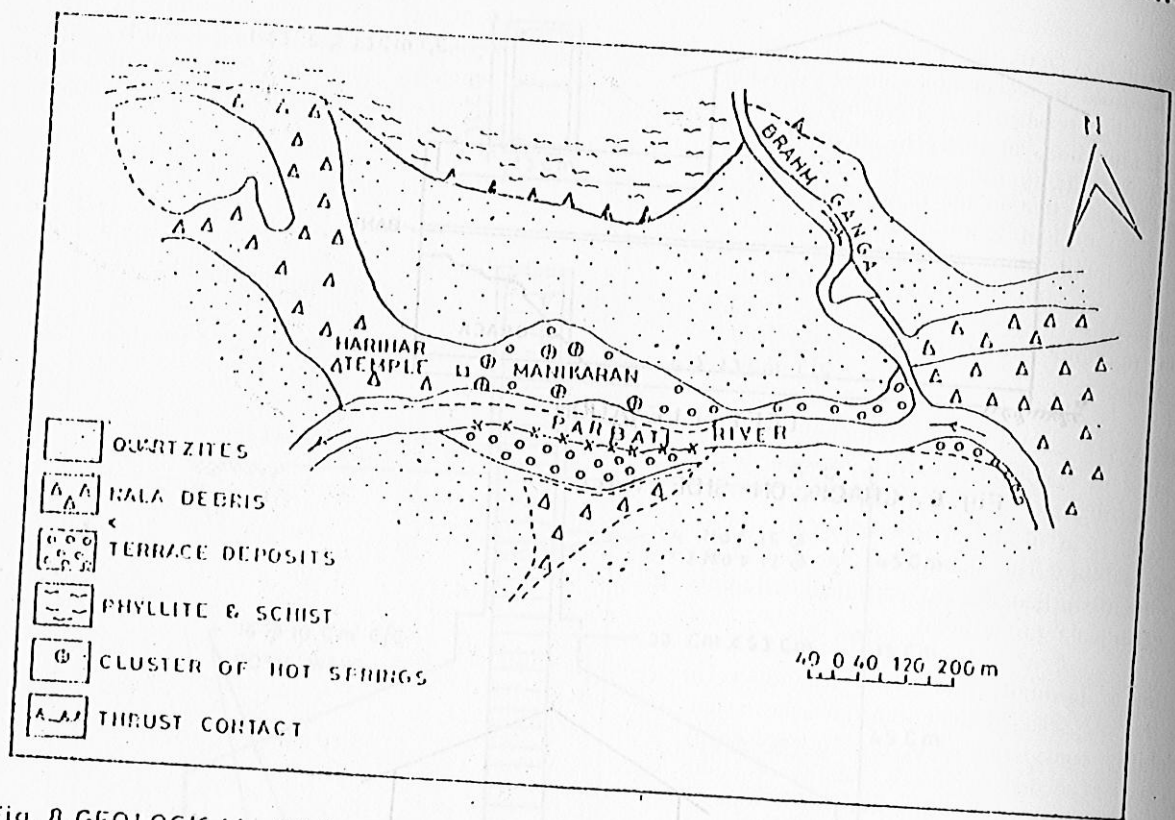
Fig. 8. GEOLOGICAL MAP OF MANIKARAN HOT SPRING AREA

belonging to pre-cambrian age (Fig. 8). The other rock types found in Parvati valley region comprise granite, gneisses, quartz-mica schist and basic intrusive rocks. The quartzites are mainly exposed between Manikaran and Jari, having regional dip ranging from 30° to 50° in north-east direction. Towards the south of this region, granite gneisses are exposed which have been considered as magmatic intrusion into the quartzite and are equivalent to Panjal traps (Post Carboniferous age).
