# Remedial Underpinning for Foundation of a Steel Tank— Construction Details

Prof Dinesh Mohan, Fellow  
Dr R K Bhandari, Member  
Chandra Prakash, Associate Member  
B Sivaram, Non-member

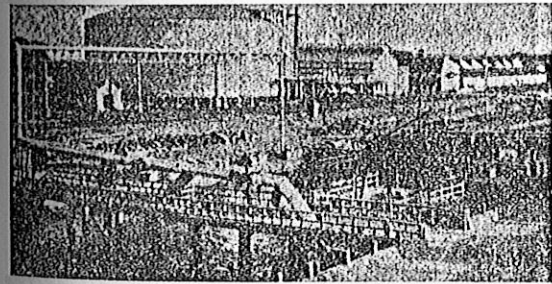
Fig 1 Ammonia tank at Willingdon Island, Cochin

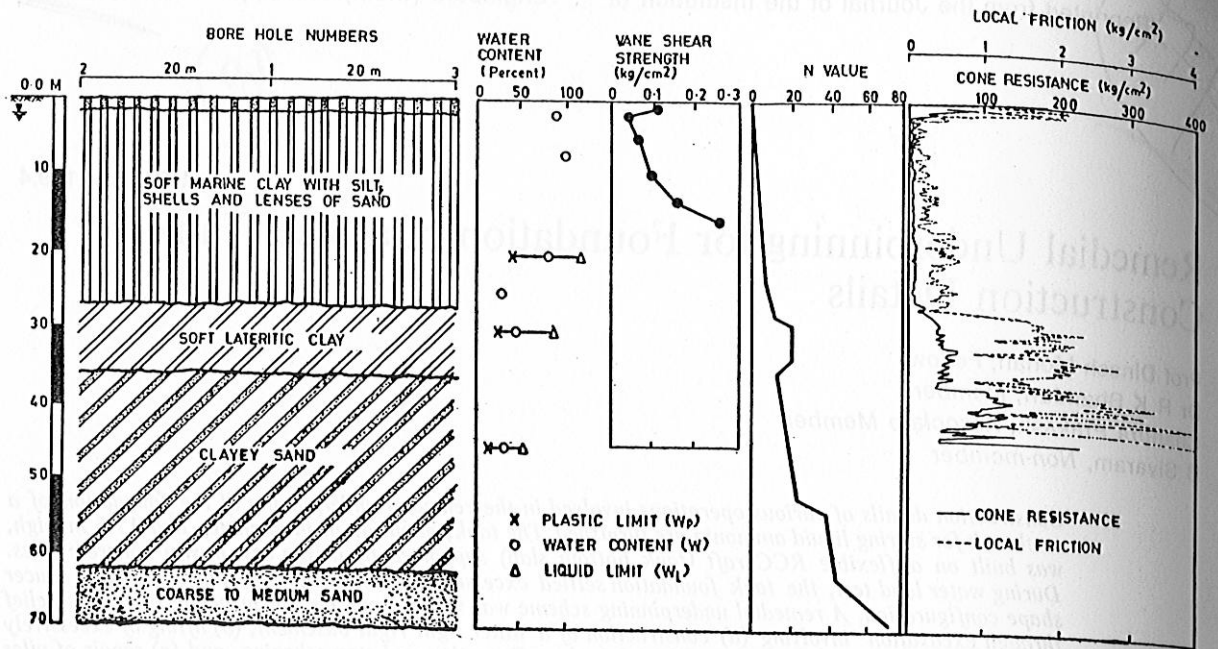
The tank which has a capacity of 10 000 t (11 600 t with overpressure) for storing ammonia is located in the Willingdon Island, Cochin (Fig 1). The island is generally made up of soft clayey silt-sand mixtures dredged from sea bottom. The subsoil strata at the tank site is given in Fig 2.

Fig 2 Subsoil characteristics at tank site

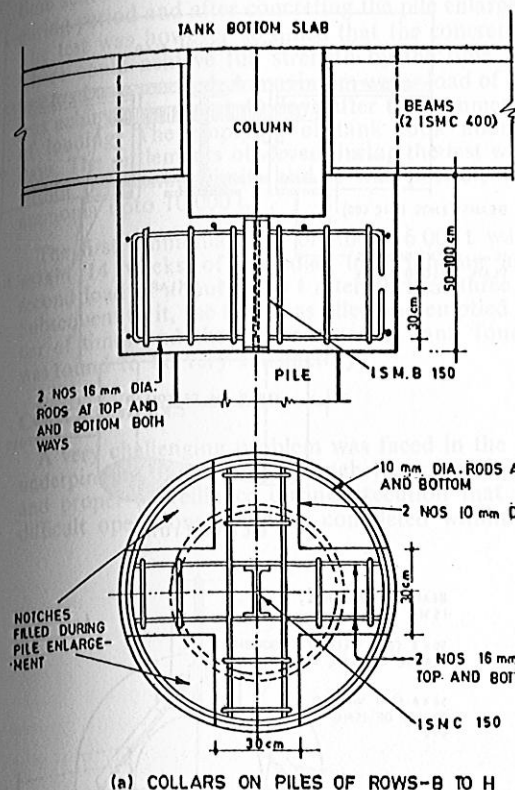
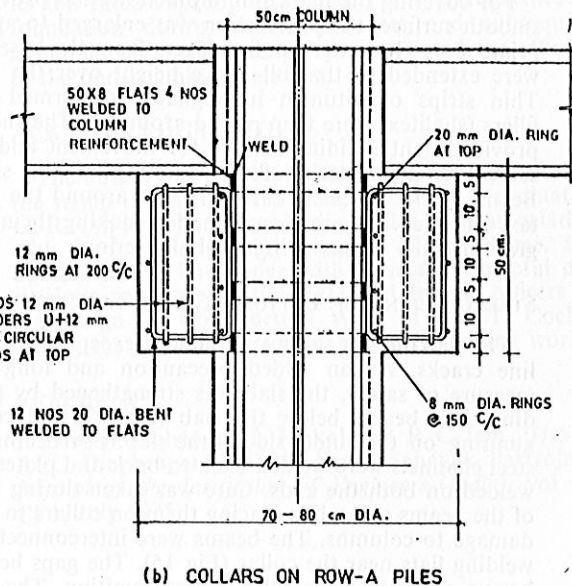
Fig 12 Details of collars

Subsequent to the lifting operation, steel I-sections (150 × 150 mm) of suitable lengths with plates welded at their ends were wedged in the space provided for hydraulic jacks [Fig 11(a)]. Screw jacks were then removed and the pile reinforcements were realigned and welded in position [Fig 11(b)]. Reinforcement cages required for providing collars on the piles were then tied; shuttering was provided and concreting done. The collars [Fig 12(a)] supported the top beams [Fig 11(c)]. In collars, a notch was provided on four sides which accommodated the reinforcement emanating from the enlargement of pile section. Thus, a proper bond between collar and pile could be achieved. The provision of notch also facilitated pouring of concrete during enlargement of pile section. Since the columns in the outermost row were not cut, their collars were different as shown in Fig 12(b). In this case, the reinforcement for collar was welded to the exposed reinforcement of columns and the collar was cast circular in shape.

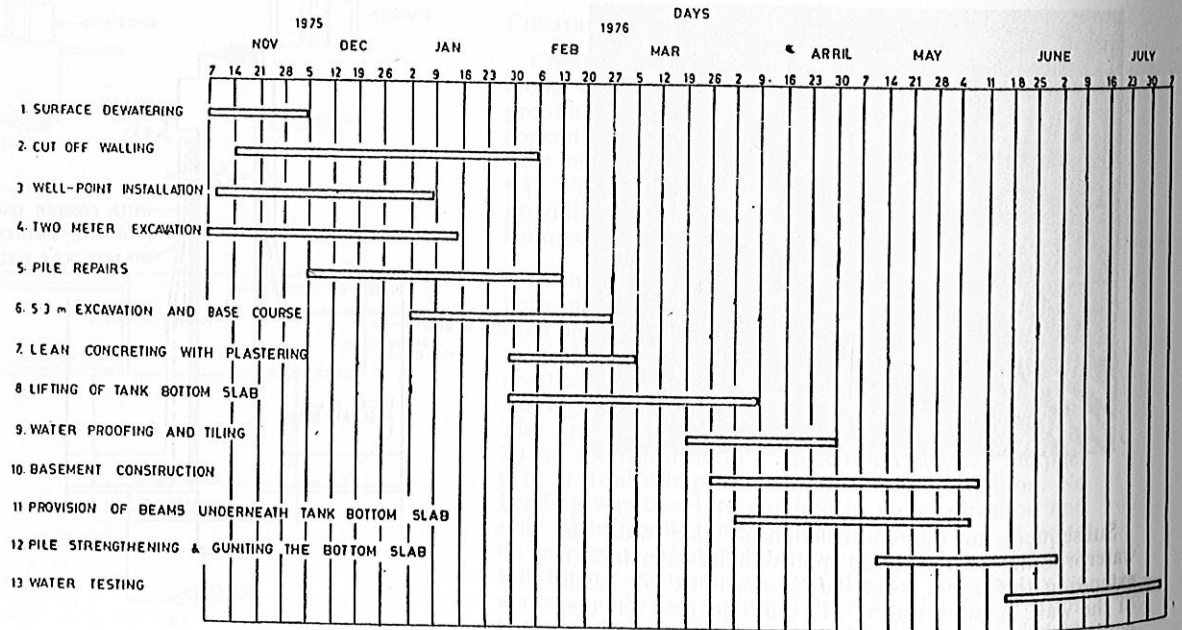
Fig 16 Time schedule for underpinning operation
