Shantanu Sarkar<sup>(1)</sup>, Amitava Ghosh<sup>(1)</sup>, Devi Prasanna Kanungo<sup>(1)</sup>,  
Zamir Ahmad<sup>(2)</sup>

## Slope Stability Assessment and Monitoring of a Vulnerable Site on Rishikesh-Uttarkashi Highway, India

- (1) Scientist, CSIR-Central Building Research Institute, Roorkee, Uttarakhand, India, e-mail: shantanu\_cbri@yahoo.co.in
- (2) Scientist, CSIR-Central Building Research Institute, Roorkee, Uttarakhand, India
- (3) Scientist, CSIR-Central Building Research Institute, Roorkee, Uttarakhand, India
- (4) Technical Officer, CSIR-Central Building Research Institute, Roorkee, Uttarakhand, India

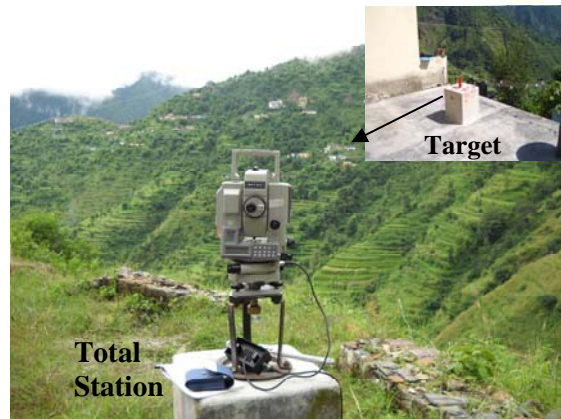
There are six houses on the slope which have shown distress manifested by development of cracks on the walls and floor subsidence. A monitoring scheme was planned to monitor the horizontal and vertical movements of these houses using Total station from a far distance outside the unstable zone. The Total station is an electronic theodolite integrated with an electronic distance meter (EDM) to obtain sloping, horizontal and vertical distances from the instrument to a particular point. Electronic Distance Measurement technology uses a ground-based, high-precision survey instrument that emits infra red wave to measure the time the wave travels

In the present study fixed points were installed as observation points on roof top of the six houses. A stable zone based on field observation was identified at a distance of 800 m from the unstable slope. The reference point was made at this location from where all the observation points could be seen without any hindrance (Fig. 5). At the time of taking observation the total station was fixed on this reference points and the data were collected from the six observation points located on the selected houses. The movement data were collected for the period August 2009 to June 2011. The horizontal and vertical movements of the observation points were calculated from the periodic monitoring data.

(a) Houses being monitored (a) and position of Total Station and target (b)
